City of Meriden Traffic Signal Study

June 2010

Project No. 2009.0603.A10

Location: TL-02 - E. MAIN AND RESEARCH

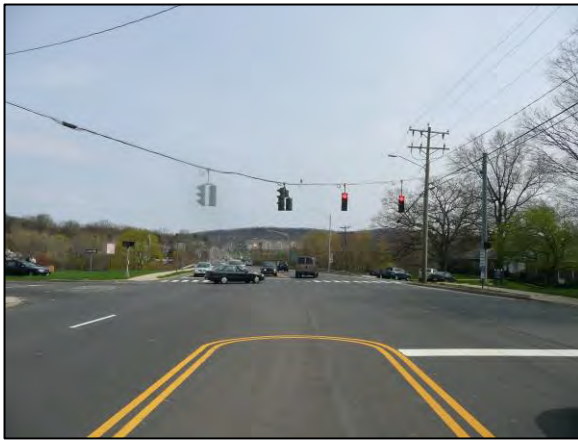
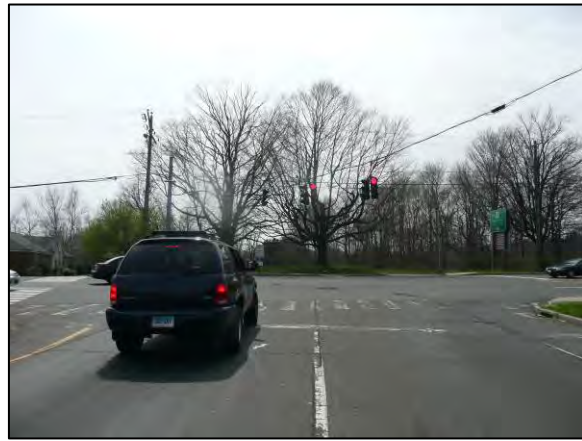
Location: TL-06 - E.MAIN AND 91 SB

(left) EB East Main and 91SB

(right) SB East Main and 91SB

Notes Vertical clearance insufficient

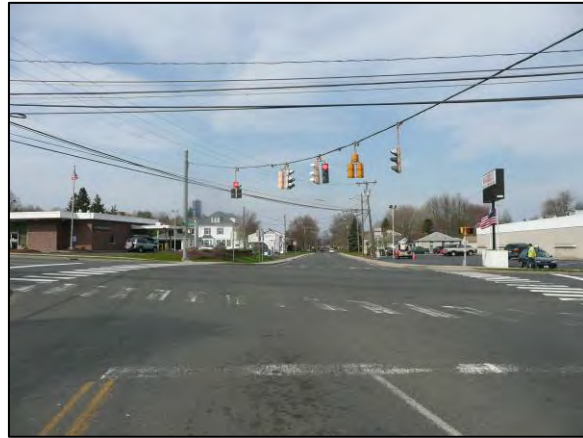
(right) NB E. Main and Gravel

Notes Pavement markings in poor condition on NB/SB approaches
Vertical clearance slightly too low

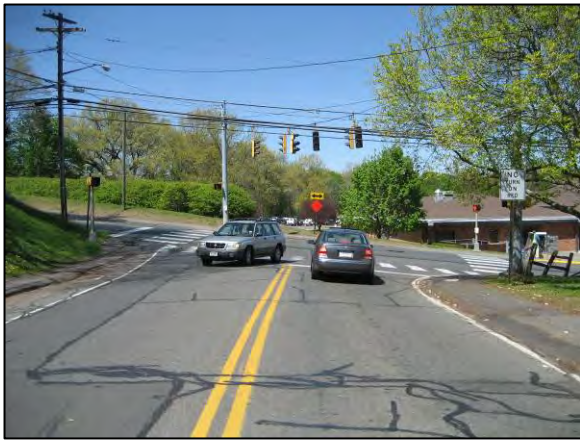
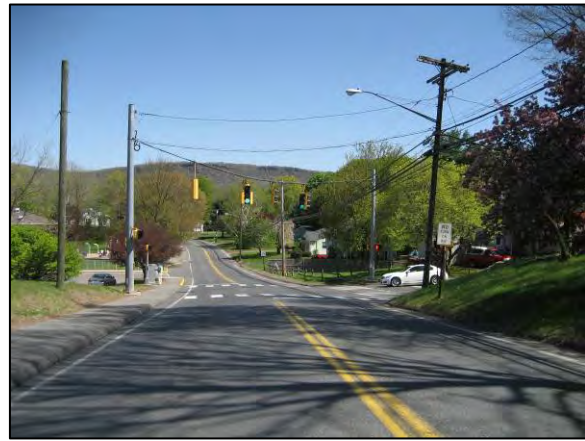
Location: TL-09 - GRAVEL AND BALDWIN

Notes
 Some paint chipping on signal heads
 Heavy pedestrian use
 Non-compliant pedestrian ramps
 NB signal heads too close to stop bar
 Vertical clearance insufficient

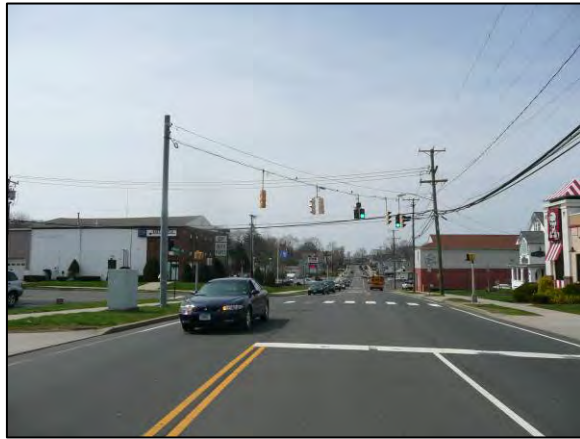
(right) WB East Main and Swain

- Notes**
- Signal heads too close to SB driveway approach
 - Signal heads need paint
 - No one-way or exit signs on exiting driveway approach
 - WB Lane Use sign knocked down
 - SE ped push button does not work
 - Screen on controller does not work

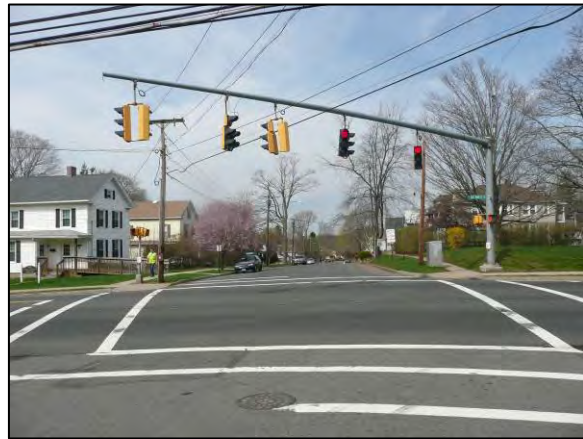
(right) NB East Main and Pearl

Notes
 Utility lines in contact with mast arm
 Old span wire appears to still be in place
 NW pedestrian head turned incorrectly
 EB signal heads too close to stop bar

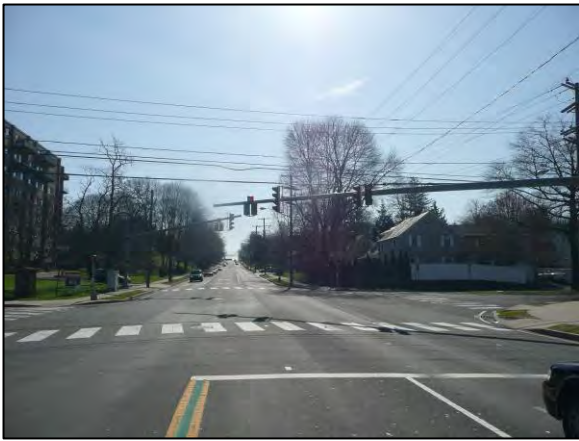
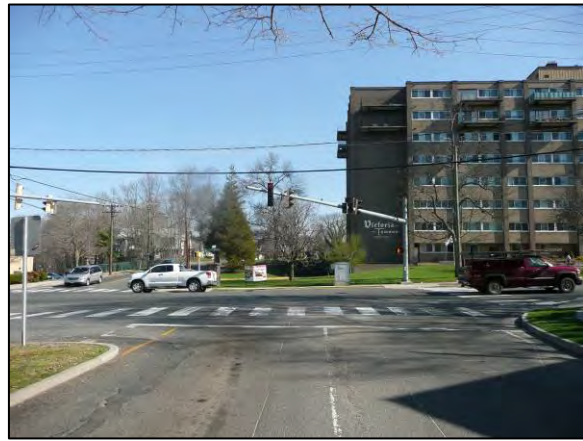
Location: TL-12 - E. MAIN AND PARKER

Notes Signal in overall good condition.

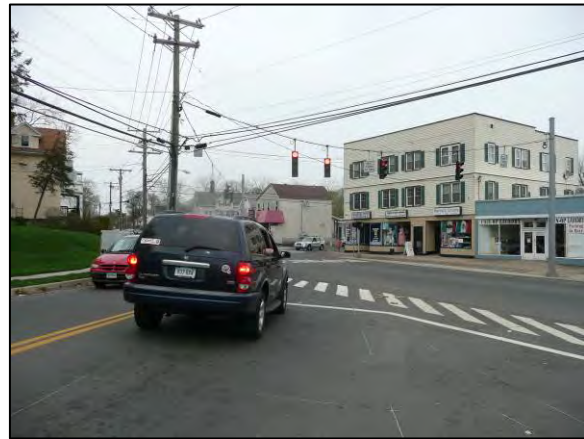
(right) EB Broad and Ann

Notes Pedestrian clearance time is excessive

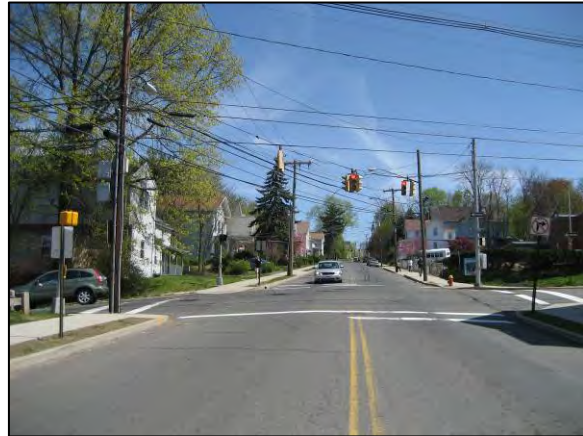
(right) Liberty St and Center St EB

Notes Signal heads in poor condition
 Signal heads too close to stop bar on NB approach
 Vertical clearance insufficient

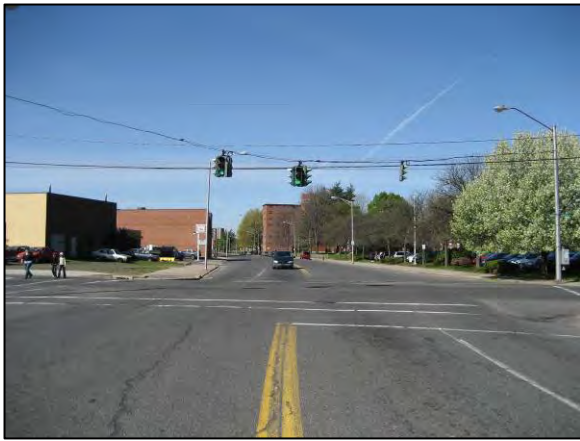
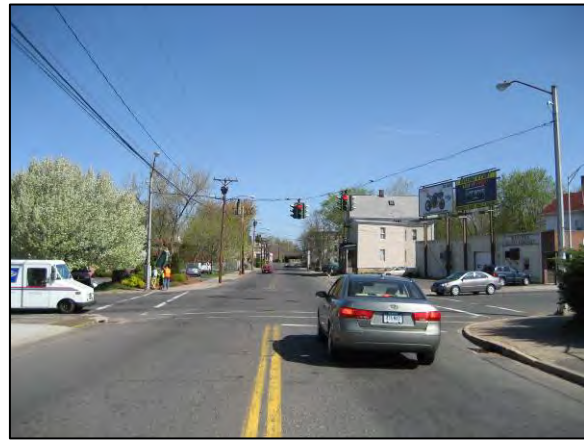
Location: TL-18 - PRATT AND CENTER

Notes No pedestrian ramps at SW, SE, & NE corner
 Vertical clearance insufficient
 Signal scheduled for partial replacement 2010 (controller & equipment)

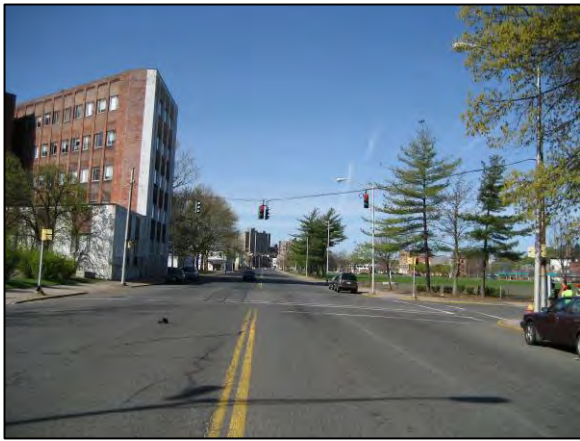
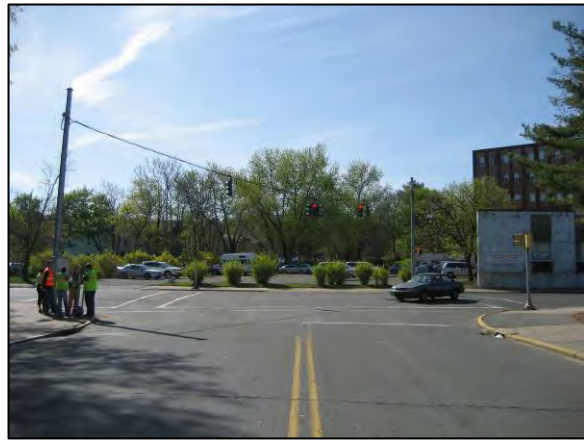
Location: TL-22 - PRATT AND MILL

Notes
 Electrical wires are exposed in ped pedestal
 Electrical wires exposed in above signal head
 No ADA ramp on SE corner or NE corner

Existing volumes should be reviewed for signal warrants before any upgrades are made to the outdated signal equipment. While signal warrants may eventually be met at the Pratt Street at Mill Street signal should redevelopment of the adjacent development site move forward, it is recommended that the signal be considered for removal in the near term and any new signal installation be delayed until a future time when conditions may warrant it.

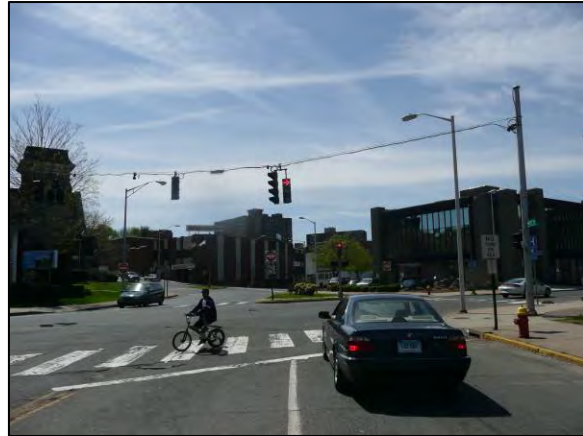
(right) SWB on Perkins

Notes
 Outdated pedestrian equipment
 Vertical clearance insufficient
 Pedestrian clearance time insufficient
 Pavement markings on NB Through/Right in poor condition

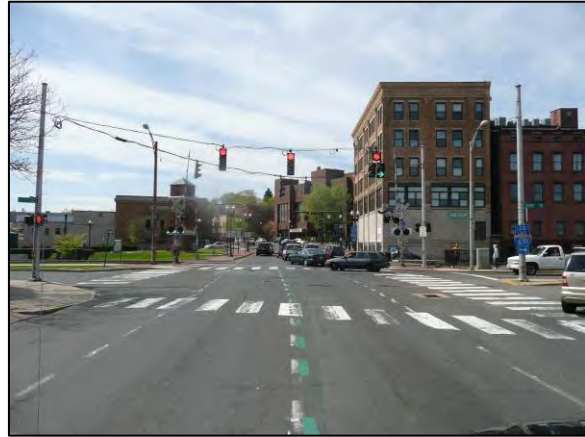
(right) WB on East Main

Notes
 RR crossing on west leg
 Mixed head size on SB traffic signals
 Outdated ped equipment
 Insufficient vertical clearance

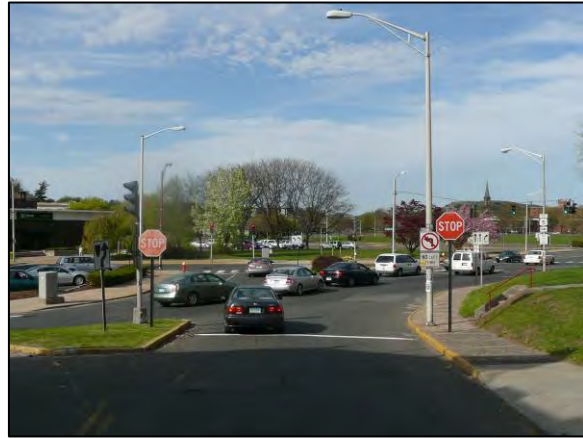
(right) NB on Crown at Perkins Intersection

The existing pedestrian signal at the intersection of Perkins Street and Crown Street is in poor condition and is rarely used. During the site visit, it was observed that the pedestrians crossing the roadway at this location frequently do not use the push button, rather choosing to cross during a gap in through traffic. Therefore, the City could consider removing the aging traffic signal concurrent with making improvements to the existing pedestrian crossing. Consider expanding the pedestrian refuge island to the south, which would reduce the crosswalk length from 66 feet to approximately 26 feet and 15 feet.

Notes
 Mast arm in poor condition.
 Flashing strobe in red signal not compliant with MUTCD
 Insufficient vertical clearance
 Insufficient pedestrian time

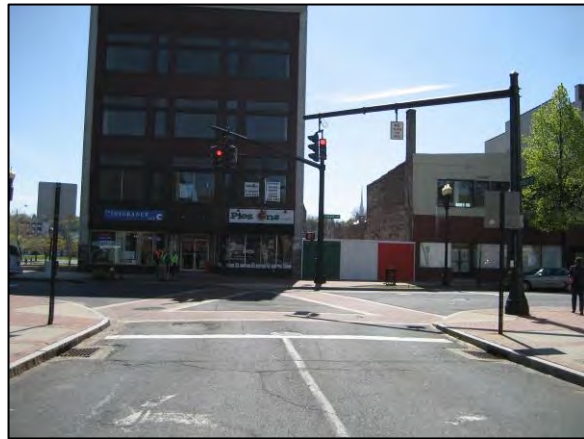
(right) Colony and Church SB

Notes 8" signal indications on side street approach

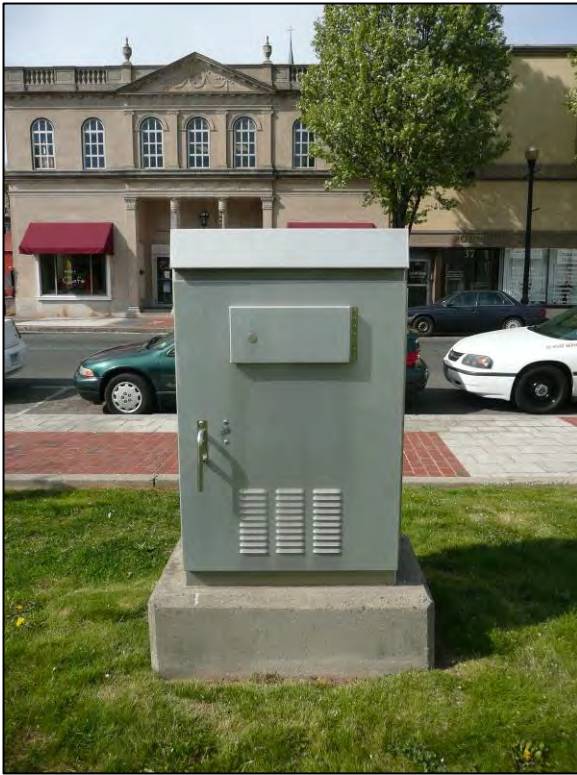
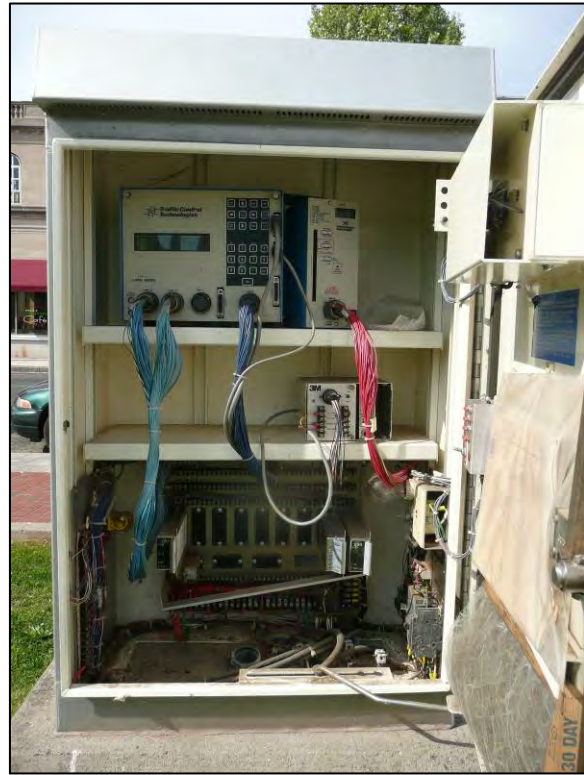
Location: TL-35 - W. MAIN AND PD

Notes Pedestrian only signal

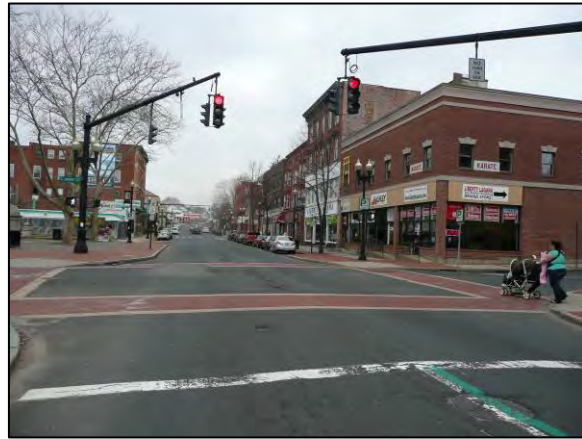
(right) WB on West Main

Notes Mixed size signal faces, 8" on side street approaches
 Preemption for W Main Street
 No do not enter or one-way signs for West Main Street

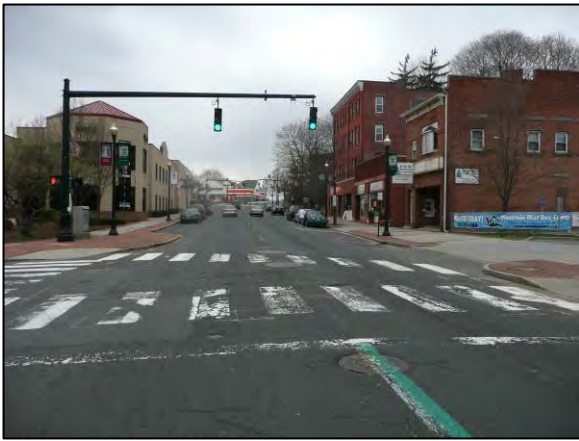
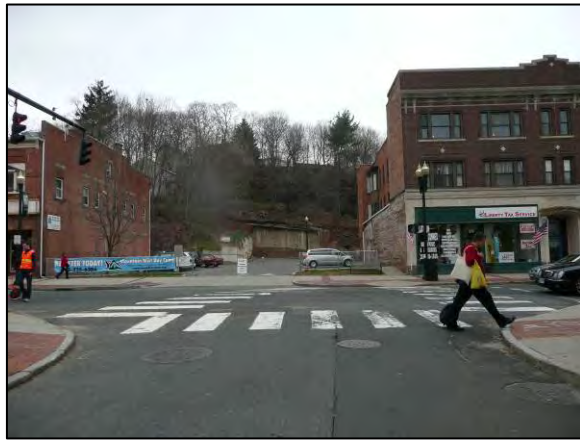
Location: TL-37 - W. MAIN AND BUTLER

Notes Signal for pedestrian use only
 Diagonal crosswalk with no HC ramp
 Poorly aligned pedestrian head on north side

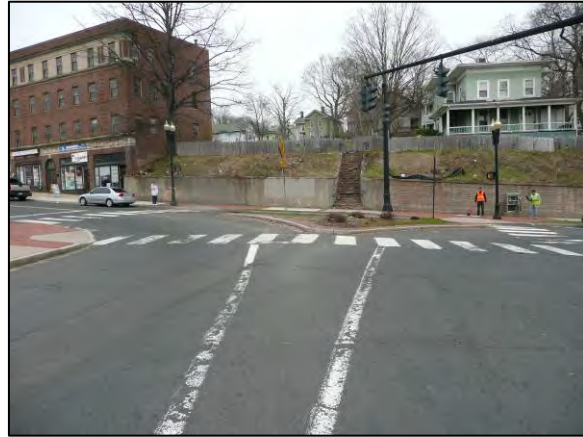
(right) NB on Cook

Notes
 Signal for pedestrian use only
 Signal heads have insufficient horizontal separation on both approaches
 WB signal heads too close to stop bar
 Insufficient pedestrian clearance time
 Pedestrians violate control - do not wait for walk signal

At Cook Avenue, it is recommended that the crosswalks be relocated to make use of the existing intersection island as a refuge for pedestrians, allowing all three crossings to cross a single lane at a time.

Fuss & O'Neill recommends that the existing crosswalks at the intersection of West Main Street at Cook Avenue be relocated to use the existing intersection island as a refuge island. This will allow pedestrians to cross a single lane at a time. This improvement will require the partial removal of the landscaping within the island, installation of four new pedestrian ramps, removal of two existing pedestrian ramps, and removal of the traffic signal.

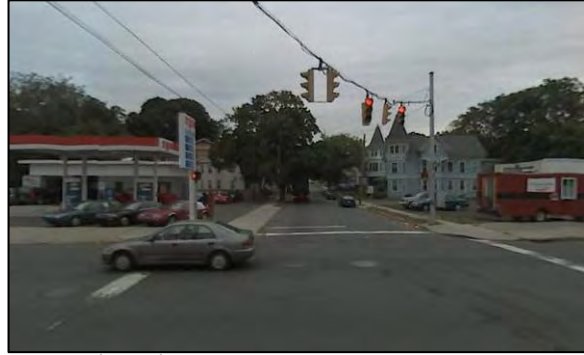
(right) West Main and Windsor NB

Notes
 Signal equipment in fair condition
 Pedestrian heads out of date
 No pavement markings on North Third Street
 Only one pedestrian head per corner
 8" signal faces
 Insufficient vertical clearance
 Unable to open cabinet

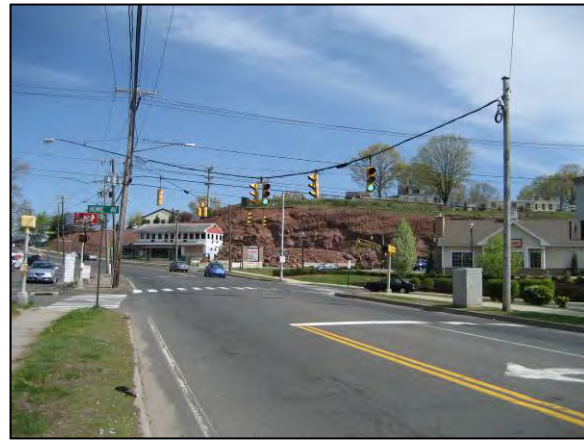
(right) West Main and Home EB

Notes Ped signal at corners of Home and W. Main are in poor condition
 Signal heads too close to stop bar on NB approach
 Vertical clearance insufficient

The side street approach of Centennial Avenue to West Main Street is skewed at a 45 degree angle and offset from the Home Avenue approach by approximately 40 feet. It is recommended that Centennial Avenue be realigned on a curved alignment to intersect West Main Street opposite Home Avenue. This will require the reconstruction of approximately 300 feet of Centennial Avenue and a full signal replacement. It will require a partial property acquisition of the retail property on the southwest corner, with a potentially small impact to the parking lot.

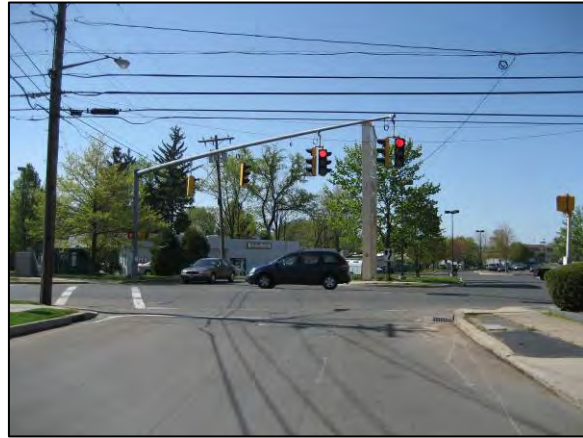
(right) West Main and Vale SB

Notes Signal heads too close to stop bar on NB approach
 Vertical clearance insufficient
 ADA ramp at NW corner in poor condition

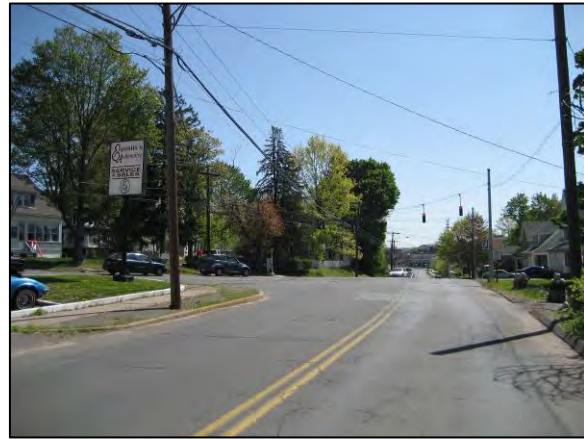
(right) West Main and Sylvan Ave NB

Notes
 Signal in overall poor condition
 WB signal head malfunctioning
 No ADA ramp at NW corner, poor sightlines, SB approach
 Size of vehicle indications too small
 Inadequate vertical and horizontal clearances to signal heads
 Insufficient distance between stop bar and signal on NE approach

This intersection has a poor alignment for all approaches, with West Main Street curving through the intersection, Johnson Avenue intersecting at an oblique angle, and Sylvan Avenue offset from the Johnson Avenue approach. It is recommended that the intersection be shifted to the west, with the Sylvan Avenue and Johnson Avenue approaches to intersect at closer to a 90 degree angle.

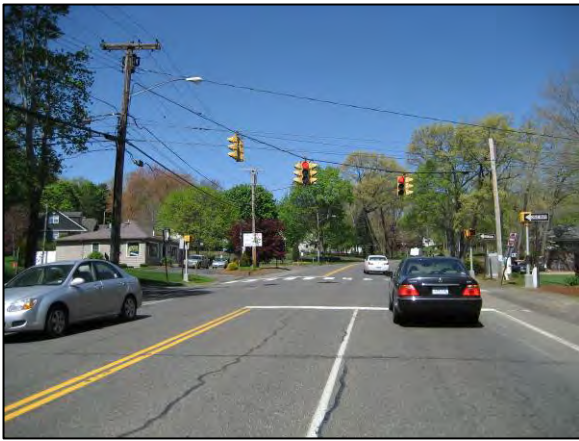
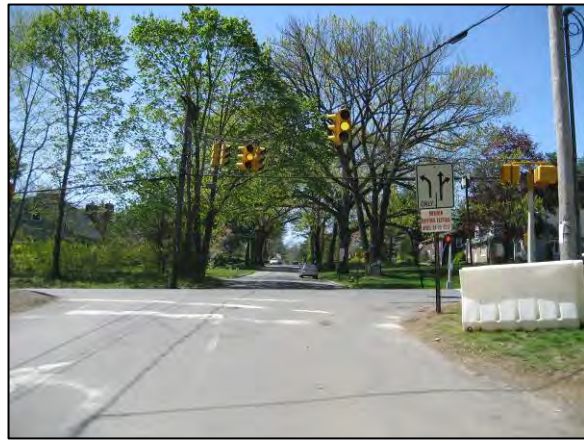
Location: TL-45 - W. MAIN AND SPRUCE

Notes Vertical clearance to signal heads insufficient
Pavement markings in poor condition

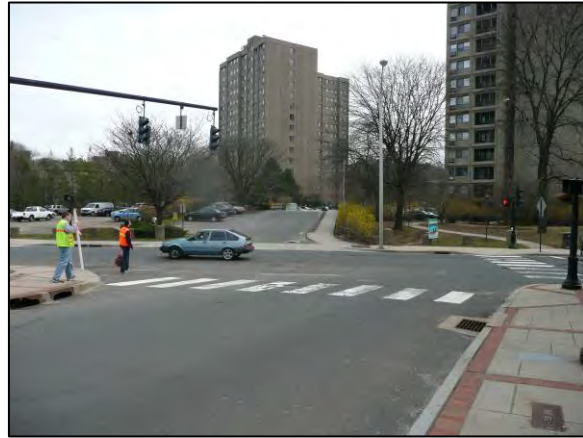
(right) SB on S. Grove

Notes
 Eastbound approach heads too far left
 Side street 8" heads
 Pedestrian head on NW corner not working (side street)
 Pushbutton not working on SW & NE corners

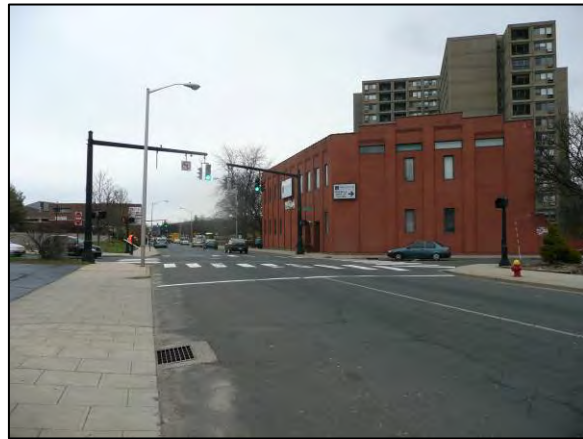
(right) EB on Hanover

Notes Mixed size signal faces
 Missing mast arm sign
 Preemption for EB

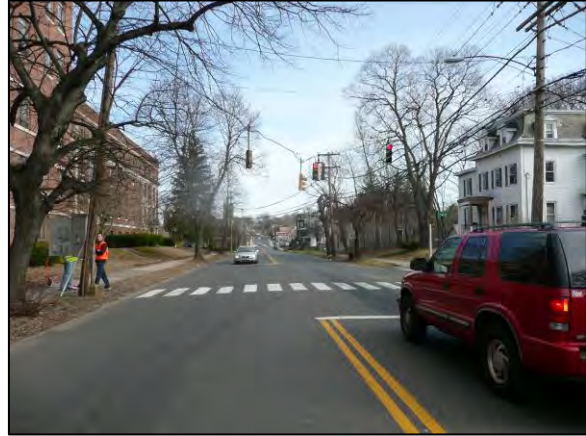
(right) NB Cook and Cooper

Notes
 8" heads
 Missing pedestrian heads - pedestals on NE/SE corner
 Incandescent signals
 WB Signal head blocks visibility to SB signal head
 Span poorly supported by leaning utility pole
 Exposed service wiring at controller base
 Truck turns entering opposing lanes

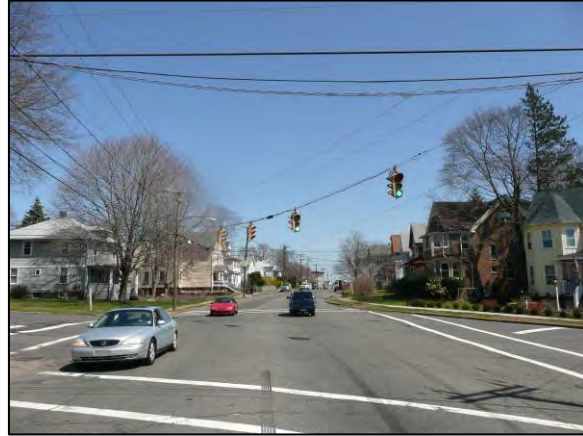
(right) EB on Hanover

Notes Missing Ped Ramp on SE corner, poor Ped Ramp s on NE/SW/NW.
 No Pedestrian Signals
 SB Detection not working
 Inadequate Vertical Clearance
 Incorrect crosswalk style

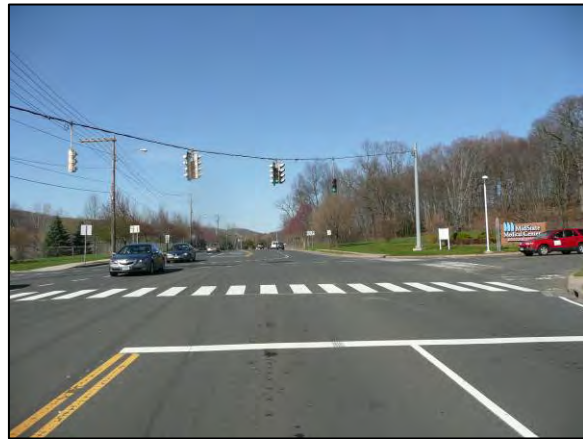
(right) NB Lewis

Notes Poor/limited pedestrian equipment, missing crosswalks on ramp approach
 Mixed LED/polycarbonate indications
 Base of SW pedestrian pedestal open

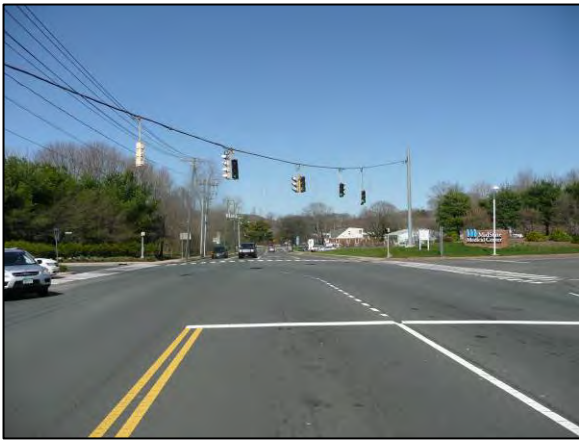
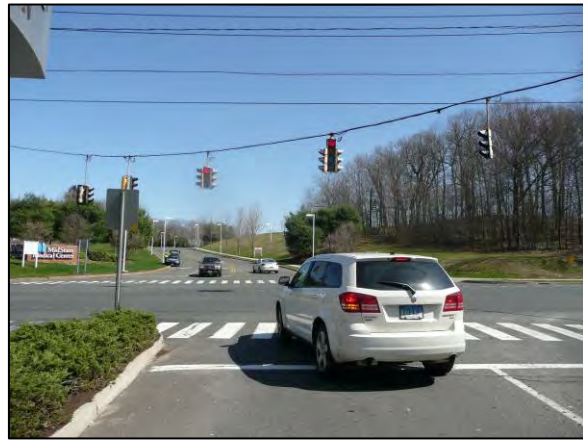
Location: TL-56 - LEWIS AND MERIDEN SQUARE

Notes Dual cluster intersection
 No pedestrian equipment at mall intersection
 8" faces at mall intersection

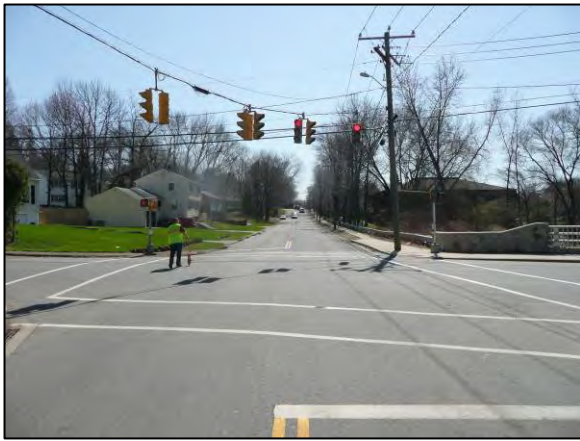
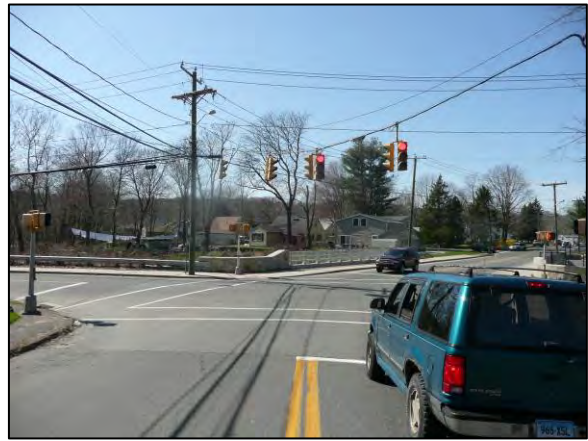
Location: TL-59 - COE AND BRADLEY

Notes Limited sight distance due to bridge abutment on EB approach
 Insufficient distance from stop bar to signal heads on WB approach
 Insufficient pedestrian clearance time

The side street approaches to Kensington Avenue are offset approximately 80 feet from each other, resulting in poor geometry for through movements and excessive lost time within the intersection. It is recommended that the southbound Bradley Avenue approach be realigned to intersect Kensington Avenue directly opposite Lewis Avenue. This will involve the reconstruction of at least 600 feet of Bailey Avenue as well as a full signal replacement. The property on the northeast corner will be heavily impacted by the realignment, requiring a partial acquisition within the adjacent parking lot or a full acquisition. In the interim condition, it is recommended that left turn arrows for the

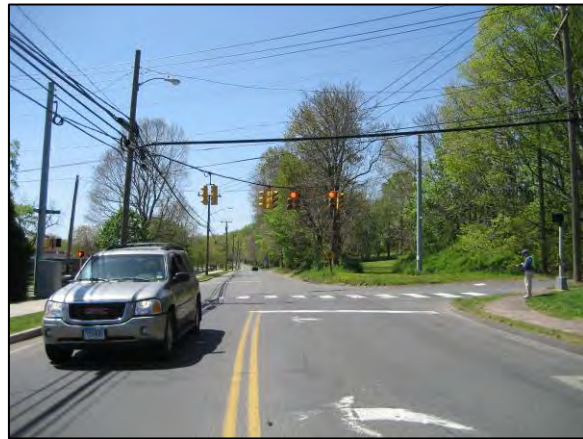
(right) Centennial Ave and Coe Ave SB

Notes Vertical clearance to signal heads insufficient

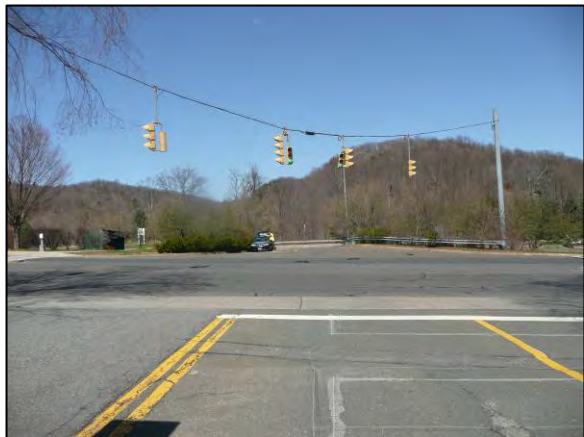
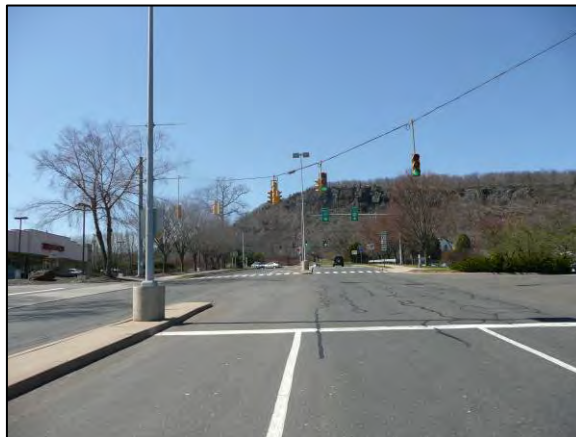
Location: TL-64 - MERIDEN SQ AND CIRCUIT CITY

The signal at the intersection of the Westfield Shopping Center Driveway appears to be unwarranted due to the vacancy at Circuit City and the undeveloped parcels north of the intersection. It is recommended that the signal either be removed or set to flash until such time that the surrounding development parcels are fully occupied, thus necessitating the use of the signal.

Notes
 NB Signal head damaged/broken (still functional)
 Almost zero side street traffic due to closed Circuit City
 EB Left Turn phase is unnecessary
 Controller cabinet access is poor

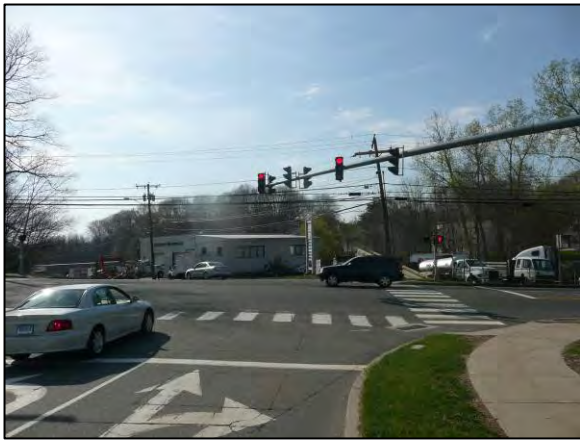
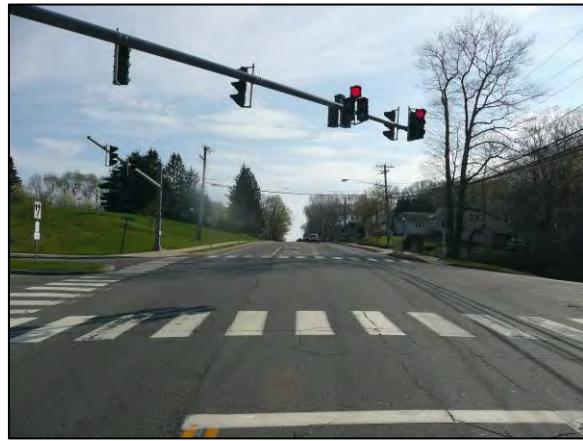
Location: TL-65 - THOMAS EDISON MAGNET SCHOOL

Sight distance is poor for both side street approaches at the intersection of North Broad Street at Golden Street and the Magnet Middle School Driveway due to the horizontal and vertical curves on Golden Street. It is recommended that the signal phasing be revised to include split phasing on the side street approach, preventing potential collisions.

Notes
 Poor sight distance for existing side street approaches
 Only one-way pedestrian head on SW corner
 Crosswalk in poor condition on EB approach
 Inadequate pedestrian crossing time on EB/WB approaches

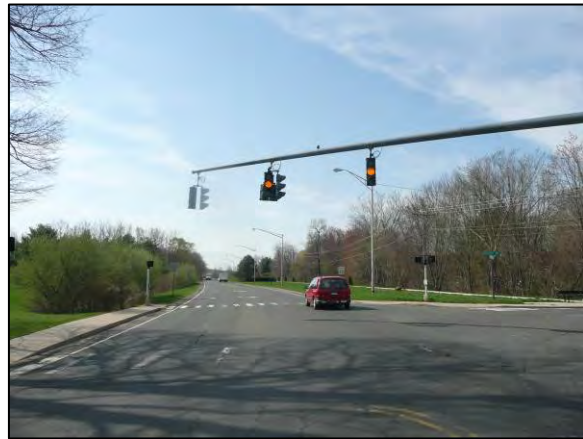
(right) SB on Research Parkway

Notes 250' sight distance on eastbound approach - signal ahead sign with road curves sign
All pavement markings in poor condition
