HAMDEN, CONNECTICUT

FARMINGTON CANAL TRAIL CROSSINGS EVALUATION STUDY

MARCH 2023

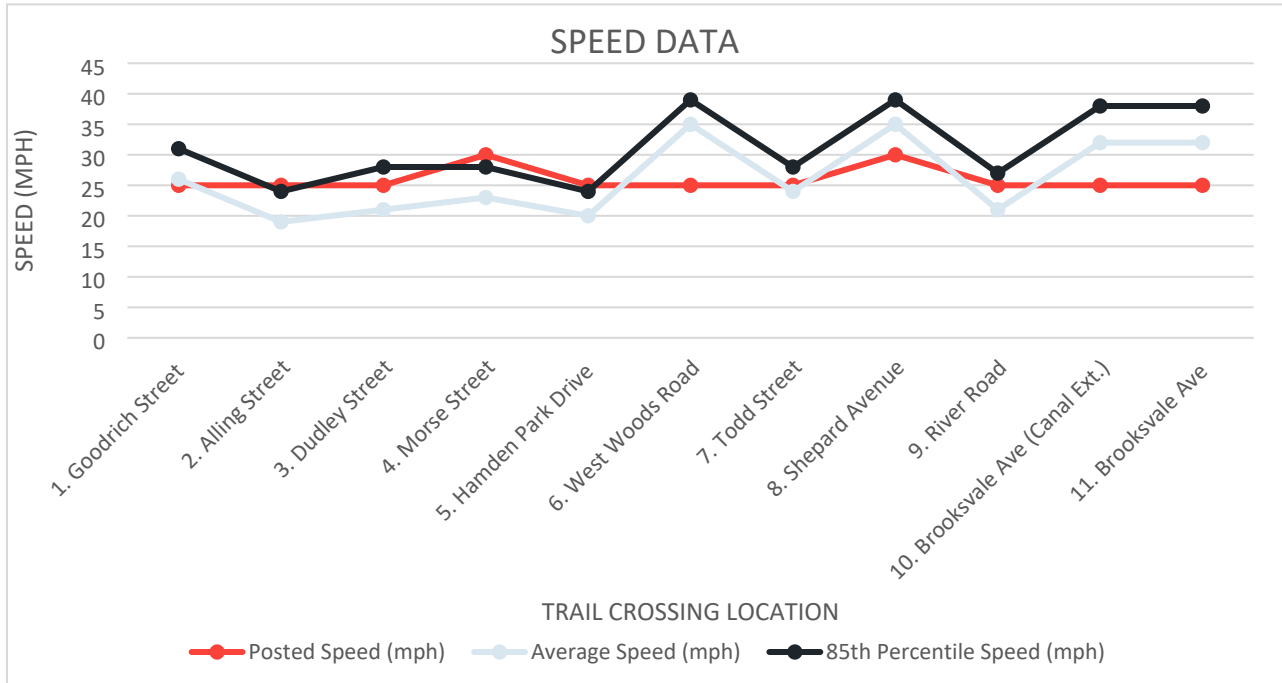
Figure 2: Posted and Observed Vehicle Speeds

Figure 2 depicts a graphical presentation of the posted and observed speed data. Observed average speeds ranged from 7 mph below the posted speed limit at Morse Street to 10 mph above the speed limit at West Woods Road. Eighty-Fifth (85th) percentile speeds were observed to be mostly above the posted speed limit, with the highest being West Woods Road and Brooksvale Avenue at 14 mph and 13 mph above speed limit respectively.

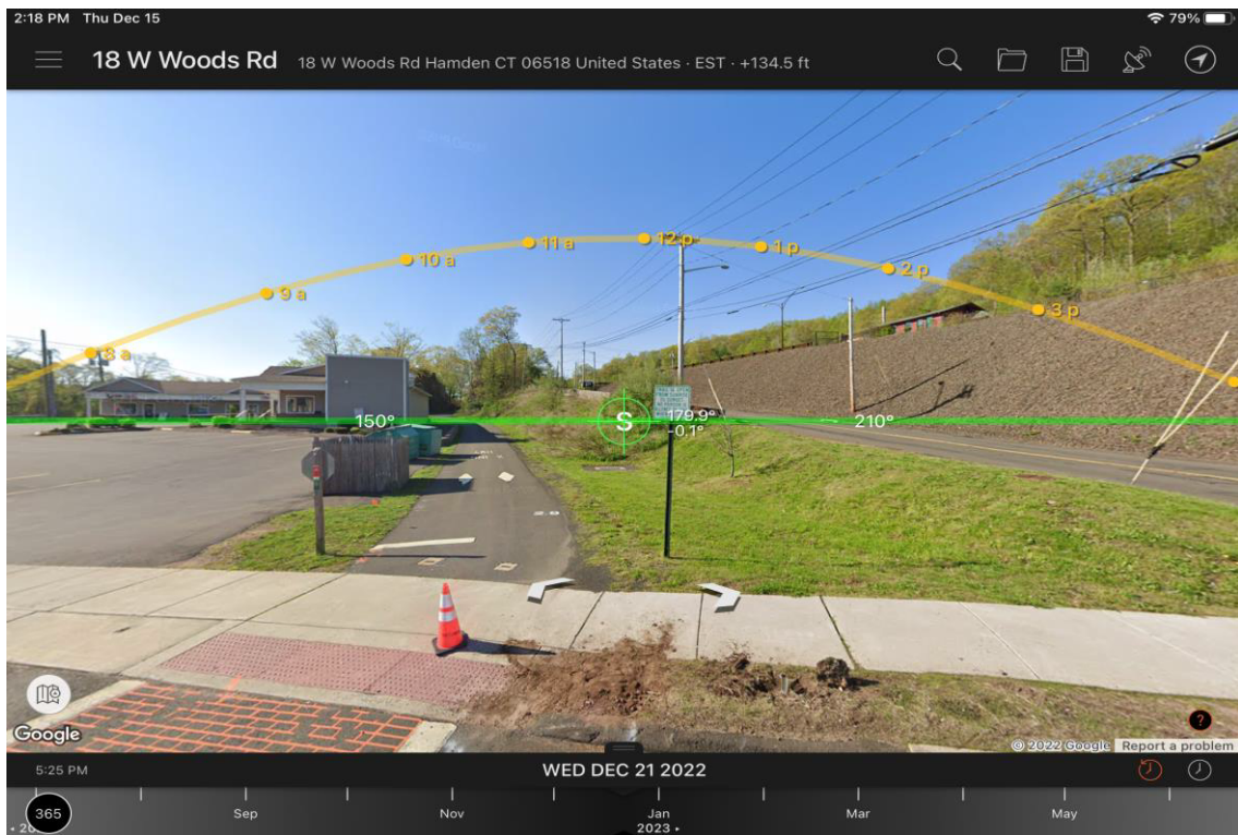
Figure 3: Solar Power Report for West Woods Road at Trail Crossing

WSP contacted an RRFB vendor to inquire about the reliability of the solar powered device. The vendor (Carmanah Technologies) conducted an initial solar power evaluation for one sample location and the information is reported below. This includes a typical number of actuations for the trail crossing and the ability to store enough solar power to run the device effectively. The full report is attached in **Appendix B** and shows the RRFBs can be reliable for operation as an enhancement to the warning signs at the crossings. RRFB devices can be either passively activated or require a pushbutton activation by the trail user.

Source: Carmanah Technologies. For full data, see **Appendix B**.

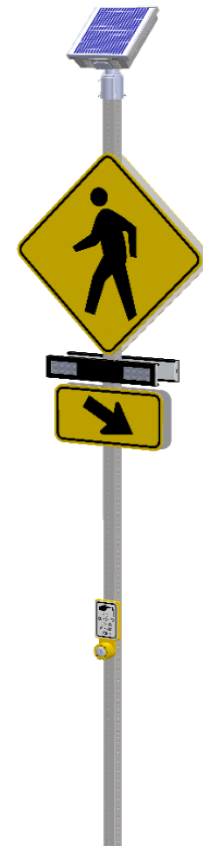
Recommended System:
R920-E
Location: 18 W Woods Rd Hamden, CT
System Configuration:

Solar Panel (Watts)	15
Solar Panel Orientation	South
Battery Capacity (Amp-Hours)	14
Fixture 1 Color and Type:	Yellow Light Bar
Number of Fixtures	2
EMS Intensity Setting	320mA
Per-Fixture Output Intensity	1555cd
Fixture Flash Pattern	RRFB
Number of Push Buttons	1
Flash Duration Setting (sec)	20

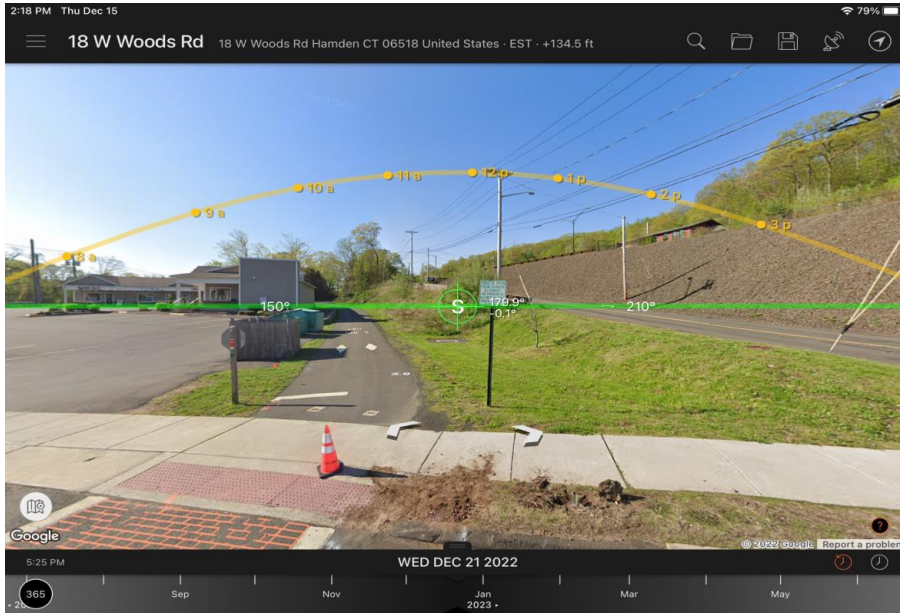
Sun Path and Shading

"The image on the left depicts the sun's path during the worst month*. Both the sun's path and shading affect the amount of available energy and determines the size and performance of the system."

Solid objects such as buildings block most light, while the effect of other objects – like trees, depending on their type and time of year– varies."

Location Shade De-rating: **20%**
