Valley Service Road Safety Study

February 2026

South Central Regional Council of Governments and
Town of North Haven

AKRF, Inc. and VN Engineers

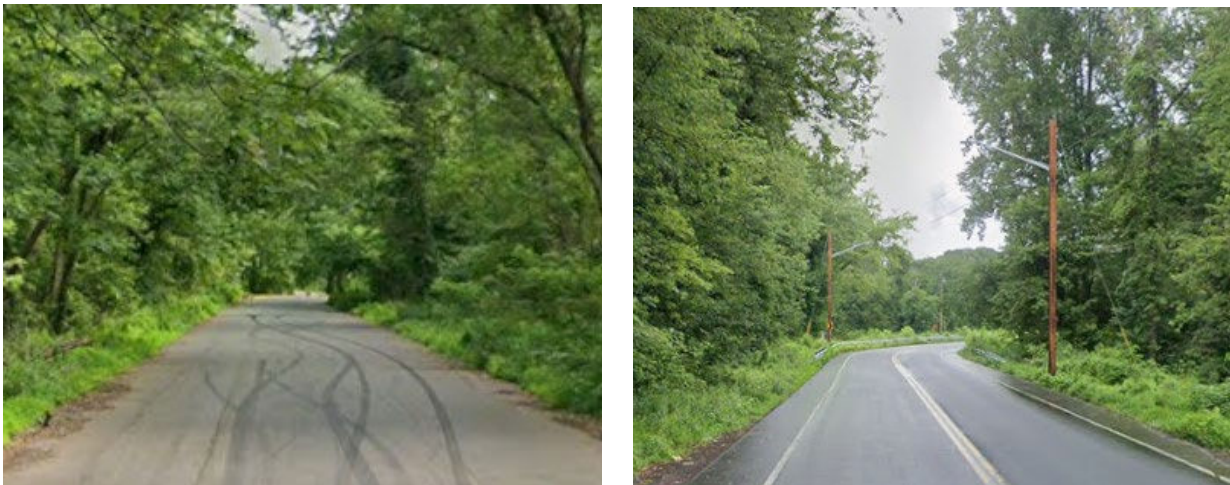
Figure 1
Valley Service Road Before and After the 2022 Corridor Extension
(Source: Google Maps)

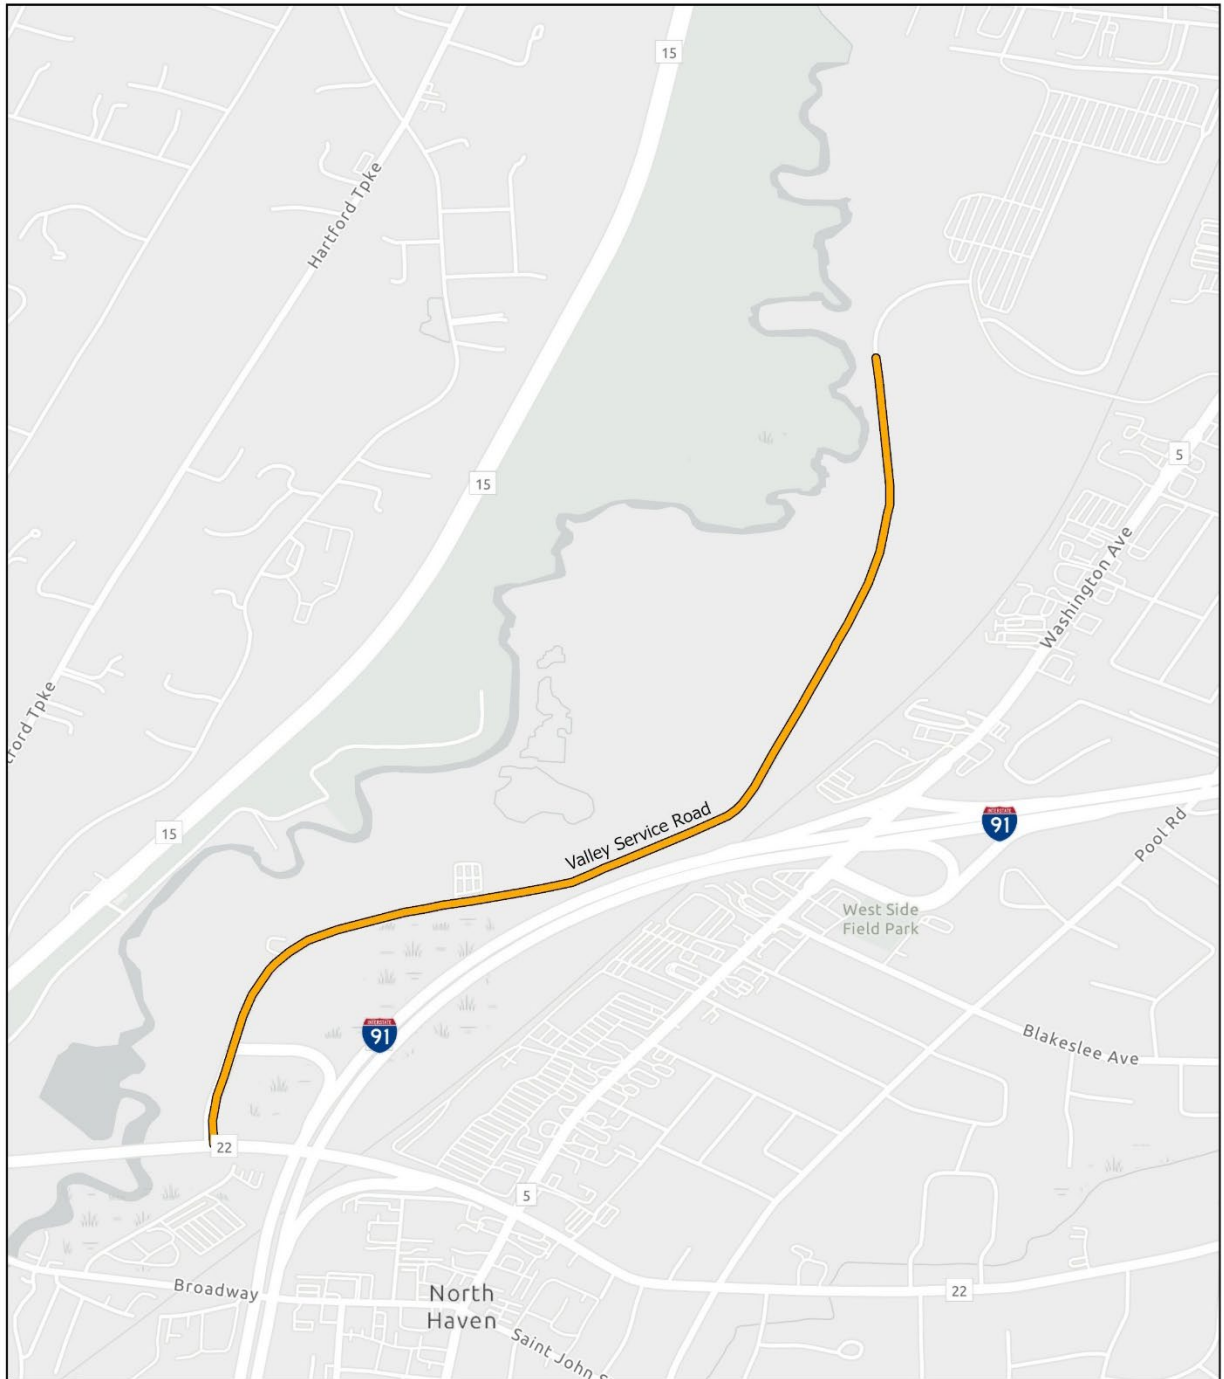
Figure 2
Valley Service Road Safety Study Area

The study area (**Figure 2**), developed in coordination with the Town of North Haven, focused on approximately 1.8 miles of Valley Service Road between Clintonville Road (Route 5 / Route 22) and approximately 950 feet south of the existing perimeter road surrounding the current Amazon Distribution Facility.

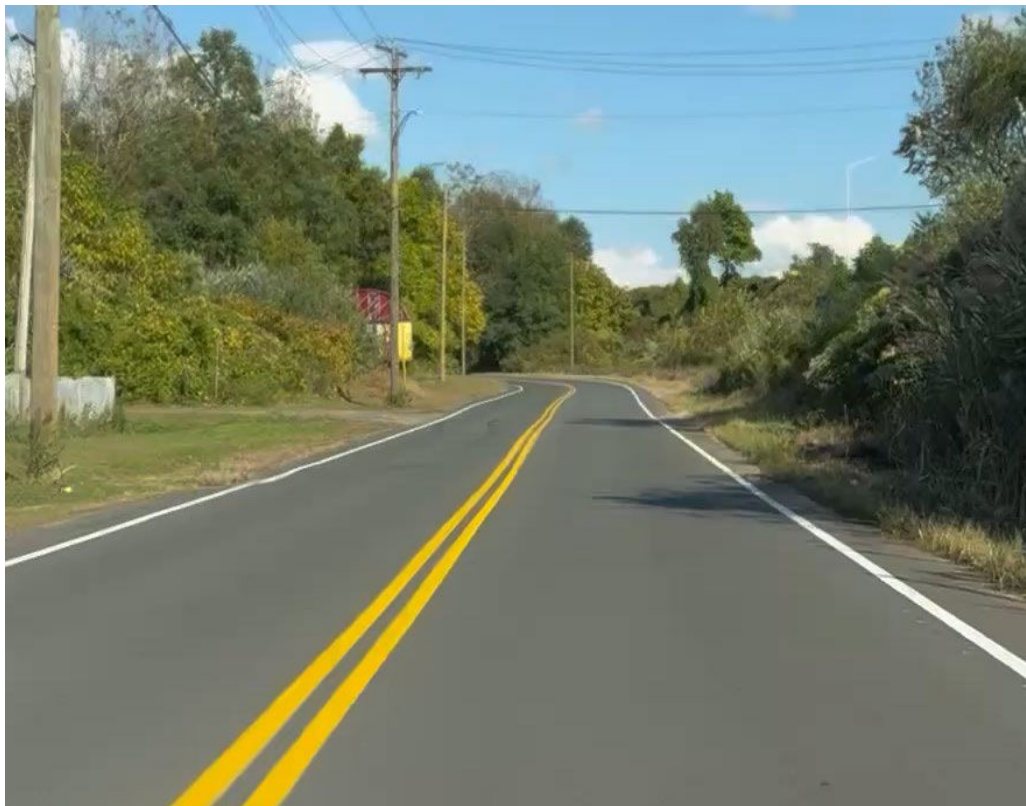
Figure 3
Valley Service Road

Valley Service Road is a town owned and maintained roadway. In addition to being classified as a north/south local roadway by the CTDOT, the corridor serves as an alternative route for north/south travel in the area. The corridor parallels the Washington Avenue corridor and provides access to the Amazon Distribution Center at 409 Washington Avenue.

At its southern terminus, Valley Service Road forms a T-intersection with Clintonville Road. The two-way stop-controlled intersection has two and three lanes on the eastbound and westbound Clintonville Road approaches, respectively. A single lane is provided along the stop-controlled approach of Valley Service Road. Continuing to the north, Valley Service Road forms another T-intersection with the southbound Interstate 91 on-ramp, with single lane approaches along both directions of Valley Service Road. The on-ramp to southbound Interstate 91 is a single lane on-ramp.

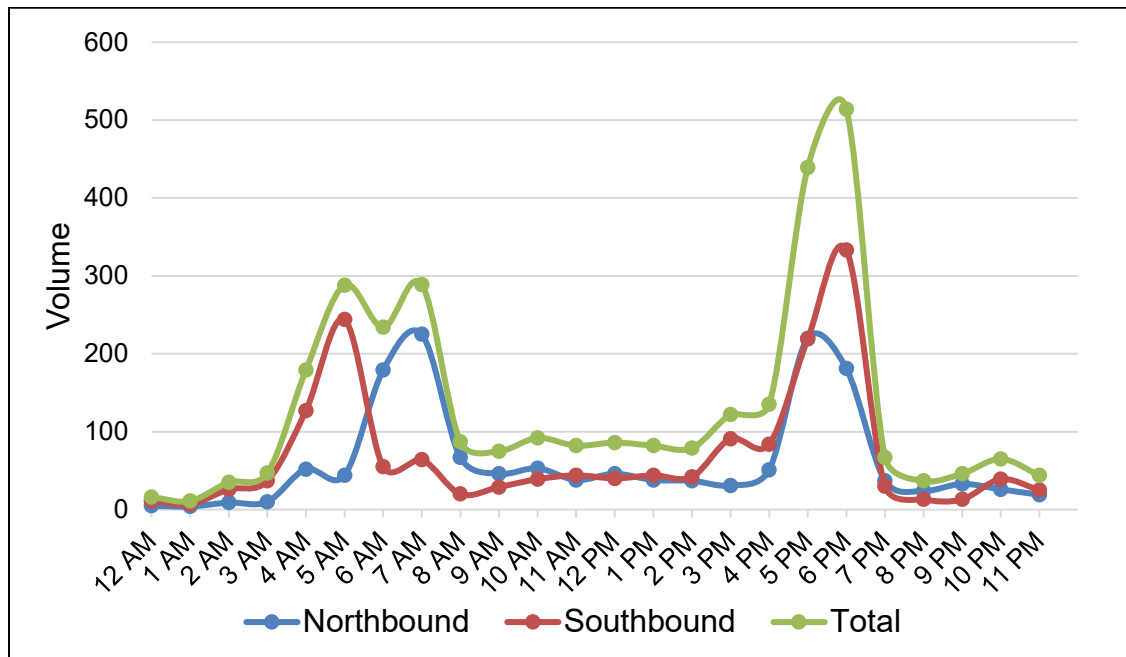
Figure 4
2025 Hourly Traffic Volumes along Valley Service Road

Figure 4 and **Table 1** provide a summary of Average Daily Traffic (ADT) collected along the Valley Service Road corridor. The ADT on Valley Service Road is approximately 3,200 vehicles per day (vpd). A review of the count data indicates a peak in traffic around 5:00 AM, 7:00 AM, and 6:00 PM, likely due to shift changes at the nearby Amazon Distribution Center. In addition, there is a slightly higher distribution of southbound traffic when compared to northbound traffic daily.

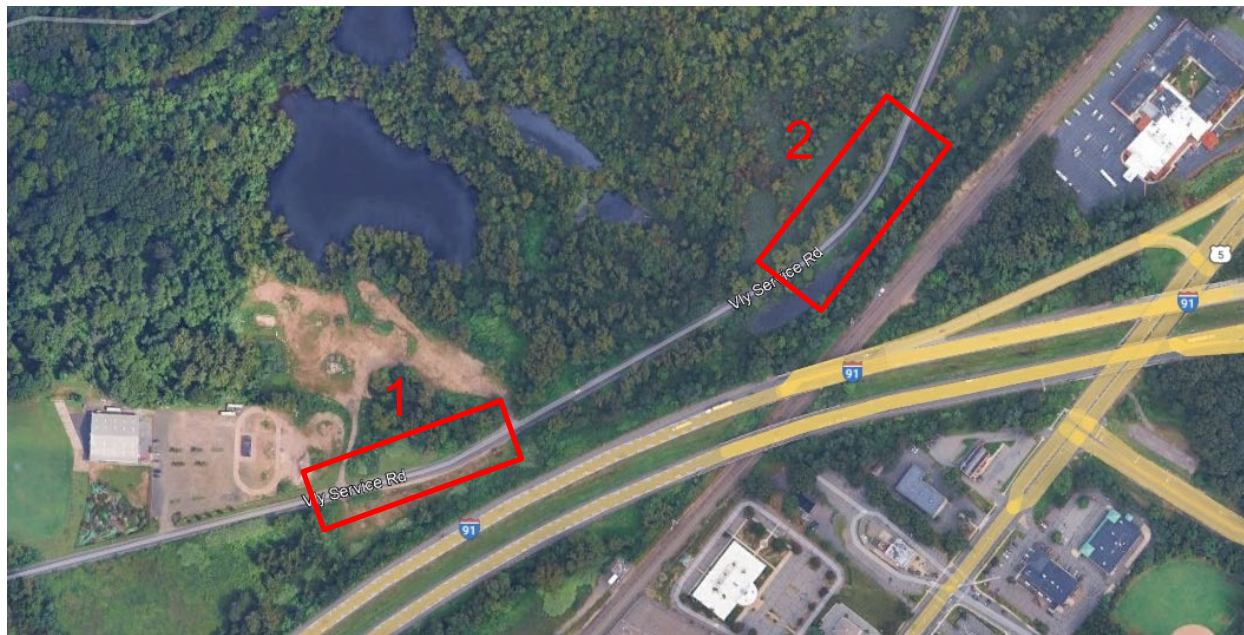
Figure 5
Horizontal Curve Speed Study Locations – Valley Service Road
 (Source: Google Earth)

A review of crash data indicates clusters of crashes occurred near two horizontal curves north of 275 Valley Service Road (see **Figure 5**, **Figure 6**, and **Figure 7**). A horizontal curve speed study was undertaken to determine the maximum comfortable speed to safely navigate each curve and to determine whether additional measures are needed to improve road safety along this segment of the corridor.

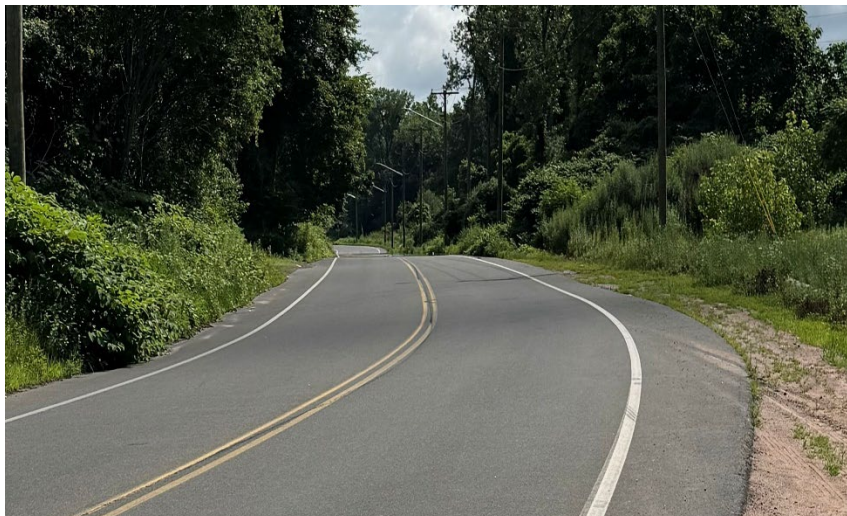
Figure 6
Valley Service Road – Horizontal Curve Speed Study Curve #1

A horizontal curve speed study is performed by driving each curve at 5 mph increments and observing the reading on a ball bank indicator mounted in the vehicle. The study is performed for both directions of the curve and during ideal weather conditions. A ball bank indicator is a steel ball encased with liquid in a curved sealed glass tube and mounted in a metal frame. The tube is bent on the arc of a circle and graduated from zero to 25 degrees, both to the right and left of the zero point. When the vehicle is driven at a steady speed on a curve the vehicle body roll and centrifugal force on the ball cause it to move out to a stable position, which is dependent on the superelevation of the curve.

Curve Location	Recommended Advisory Speed
1	40 mph
2	35 mph

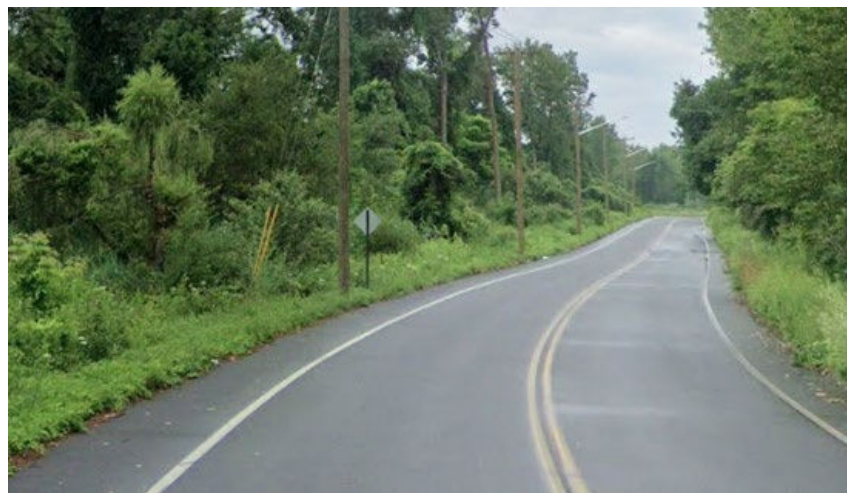
Figure 7
Valley Service Road – Horizontal Curve Speed Study Curve #2

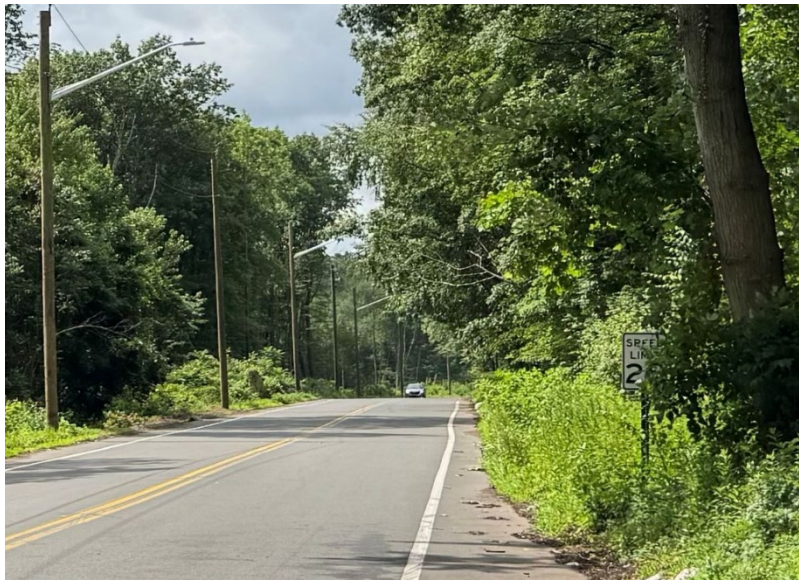
Figure 8
Obscured Speed Limit Sign on Valley Service Road

Vegetation partially obscures some of the existing signage along the corridor (see **Figure 8**). Vegetation control helps to preserve the visibility of signage along the corridor along with reducing the risk of physical impacts with vehicles in the travel lane. This is especially important since there is a narrow shoulder between the edge of the travel lane and surrounding foliage and branches.

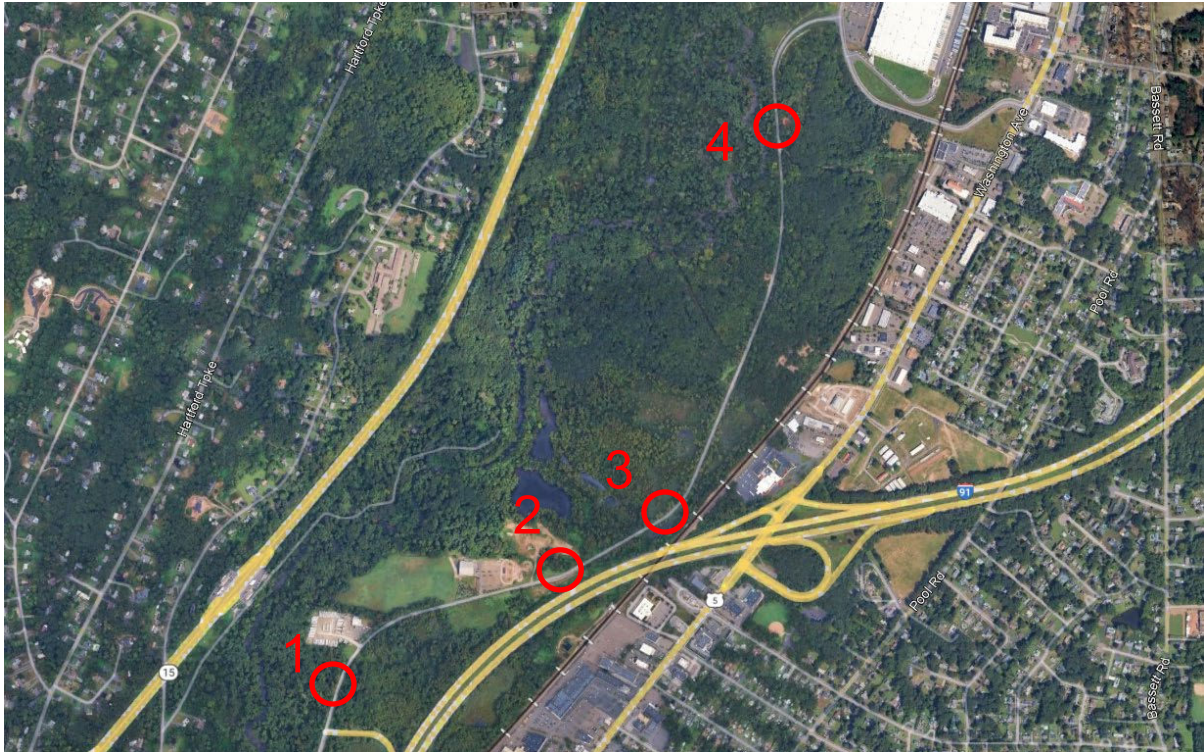
Figure 10
Locations Identified for Vegetative Removal or Pruning
(Source: Google Earth)

Roadway signage is crucial in notifying motorists of posted speed limits, upcoming changes in roadway alignment, and other warning signs essential for traversing the roadway safely. Several undeveloped areas along the Valley Service Road study area contain overgrown vegetation that may partially or fully obscure existing signage throughout the year. As shown in **Figure 10**, the following locations have been identified in which vegetative removal or pruning is recommended to improve corridor signage visibility year-round:

1. Posted speed limit sign located to the north of the southbound Interstate 91 on-ramp in the northbound direction (see **Figure 11**).
2. Billboard located within Horizontal Curve #1 in the southbound direction (see **Figure 12**).
3. Chevron alignment signage located around Horizontal Curve #2 in both directions of travel (see **Figure 13** and **Figure 14**).
4. Posted speed limit sign located at the northern study limit in the southbound direction (see **Figure 15**).

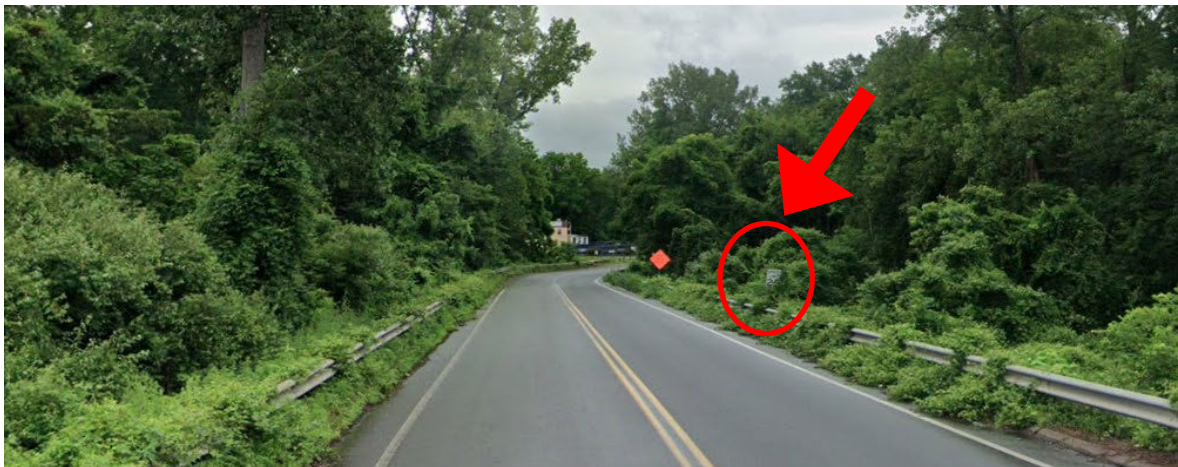
Figure 11
Vegetative Removal or Pruning Location 1 – Speed Limit Sign in Northbound Direction

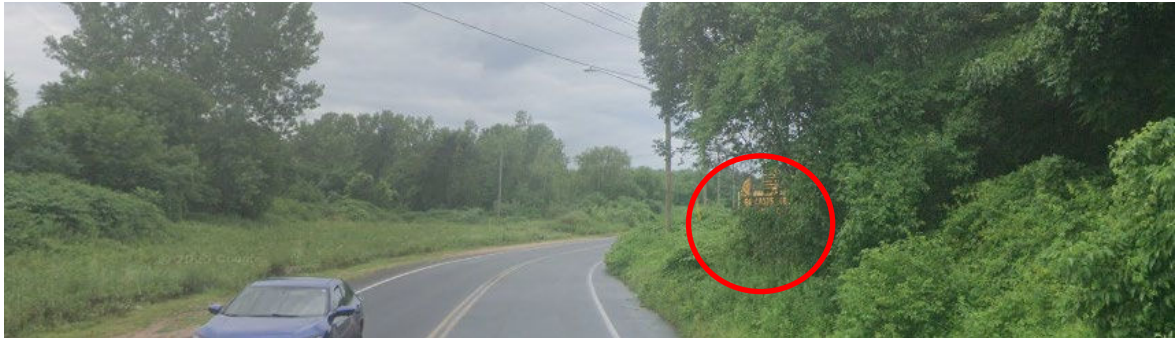
Figure 12
Vegetative Removal or Pruning Location 2 – Billboard in Southbound Direction

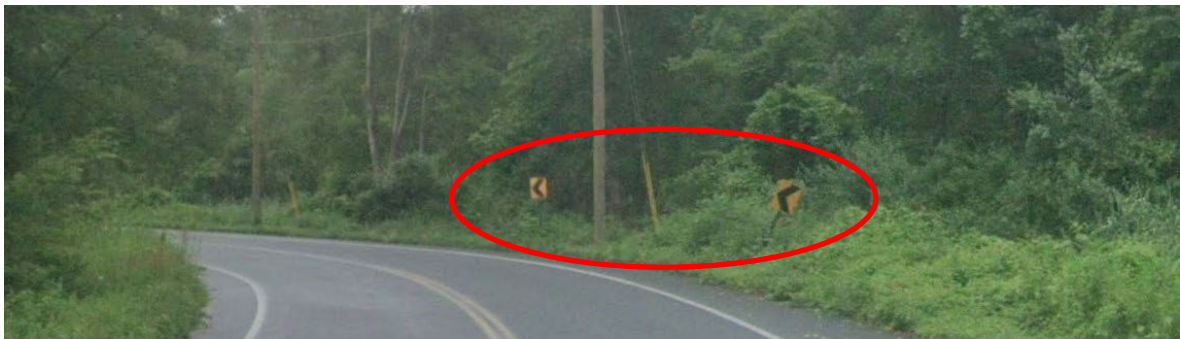
Figure 13
Vegetative Removal or Pruning Location 3 – Chevron Alignment Signage in Northbound Direction

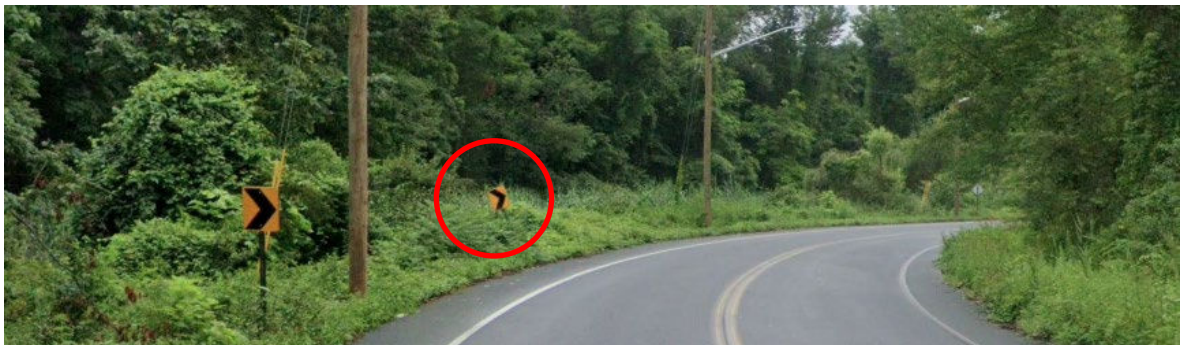
Figure 14
Vegetative Removal or Pruning Location 3 – Chevron Sign in Southbound Direction

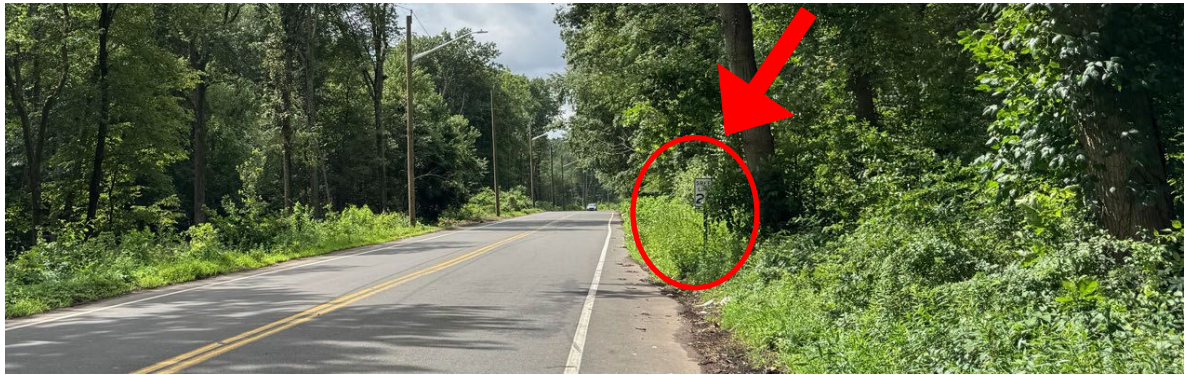
Figure 15

Vegetative Removal or Pruning Location 4 – Speed Limit Sign in Southbound Direction

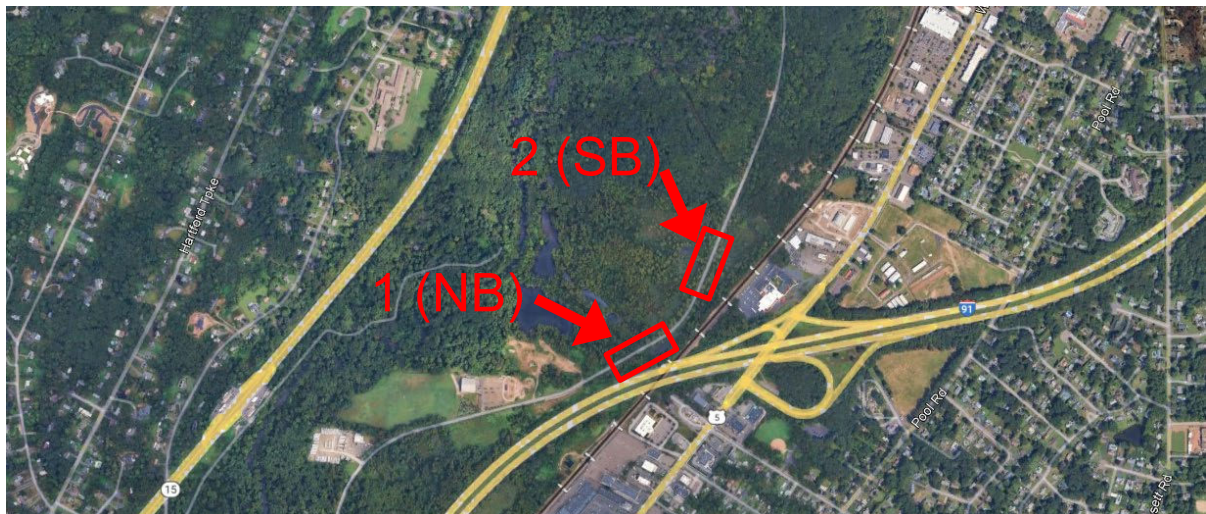
Figure 16

Potential Locations for Installing Additional Speed Limit Signage (Source: Google Earth)

Per recent observations of the study corridor from February 2026, AKRF noticed the installation of additional speed limits signs within the middle portion of the roadway prior to Horizontal Curve #2 in both directions of travel. It is recommended that the Town of North Haven continue to maintain those signs. If the signs are temporary installations, it is recommended that the Town of North Haven permanently install one speed limit sign for each direction of travel prior to Horizontal Curve #2 as pictured in **Figure 16** below. Speed limit signage installed in this manner may act as ancillary warning signage reminding motorists to slow down prior to the curve.

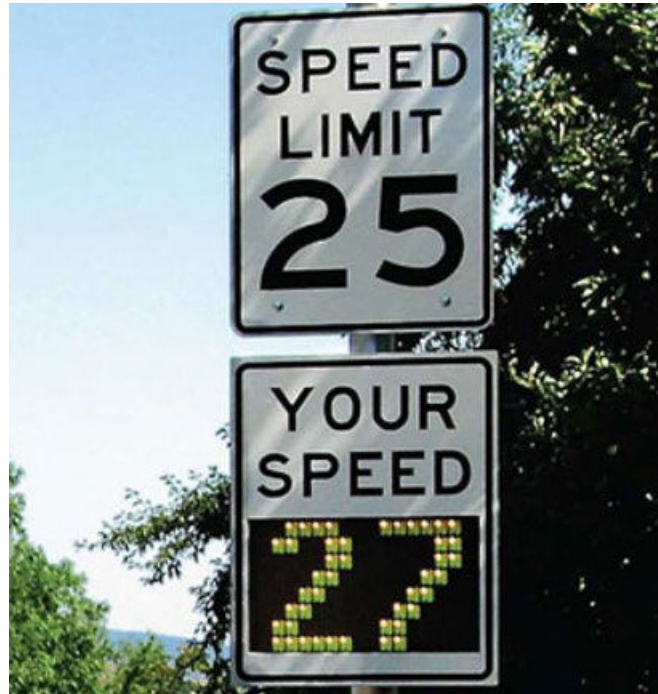
Figure 17
Speed Limit Sign with Vehicle Speed Feedback Sign
(Source: FHWA)

Furthermore, AKRF observed digital speed feedback signs mounted along with the speed limit signs within the vicinity of Horizontal Curve #2. The Town of North Haven should consider maintaining the vehicle feedback signs or making them permanent installations to assist in reducing operative speeds along the curve. The vehicle feedback signs may be mounted directly below posted speed limit signage per MUTCD guidance, as pictured in **Figure 17** below. Digital speed feedback signs may be used in conjunction with additional LEDs to flash lights when motorists reach speeds exceeding pre-programmed thresholds, such as 10 mph over the posted speed limit.

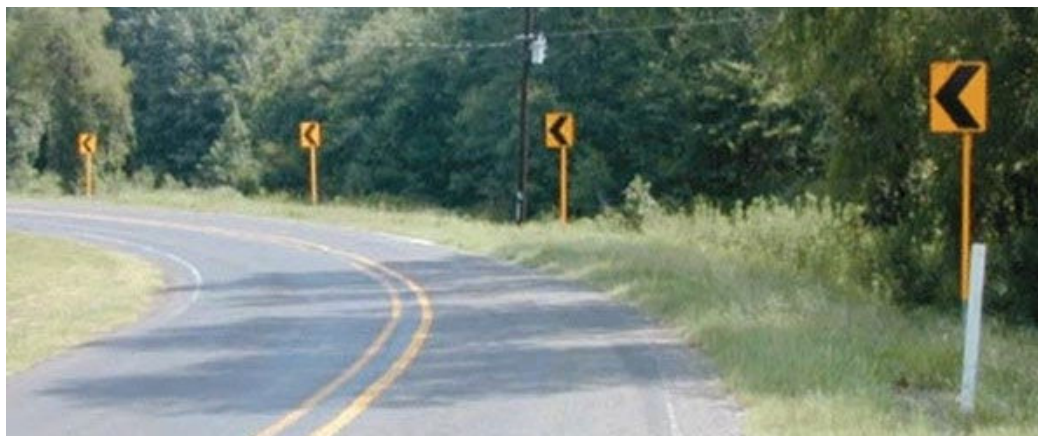
Figure 18
Chevron Alignment Signage with Retroreflective Sheeting
(Source: FHWA)

Signage around horizontal curves are crucial in notifying motorists of upcoming changes in roadway alignment, especially at night, in rain, or other weather conditions that may hinder visibility. The two horizontal curves pictured in **Figure 5** earlier in the report are of particular concern due to the large percentage of crashes that occurred along the segment at or near the curves (13 of 28 crashes). A majority of the 13 crashes occurred at night (eight crashes or approximately 62 percent) with five of the 13 crashes having occurred in rain or snow (approximately 38 percent). To address the high percentage of crashes in conditions of low visibility, the Town should consider upgrading the existing chevron alignment signage along the second horizontal curve by adding retroreflective sheeting to the signposts as shown in **Figure 18**.

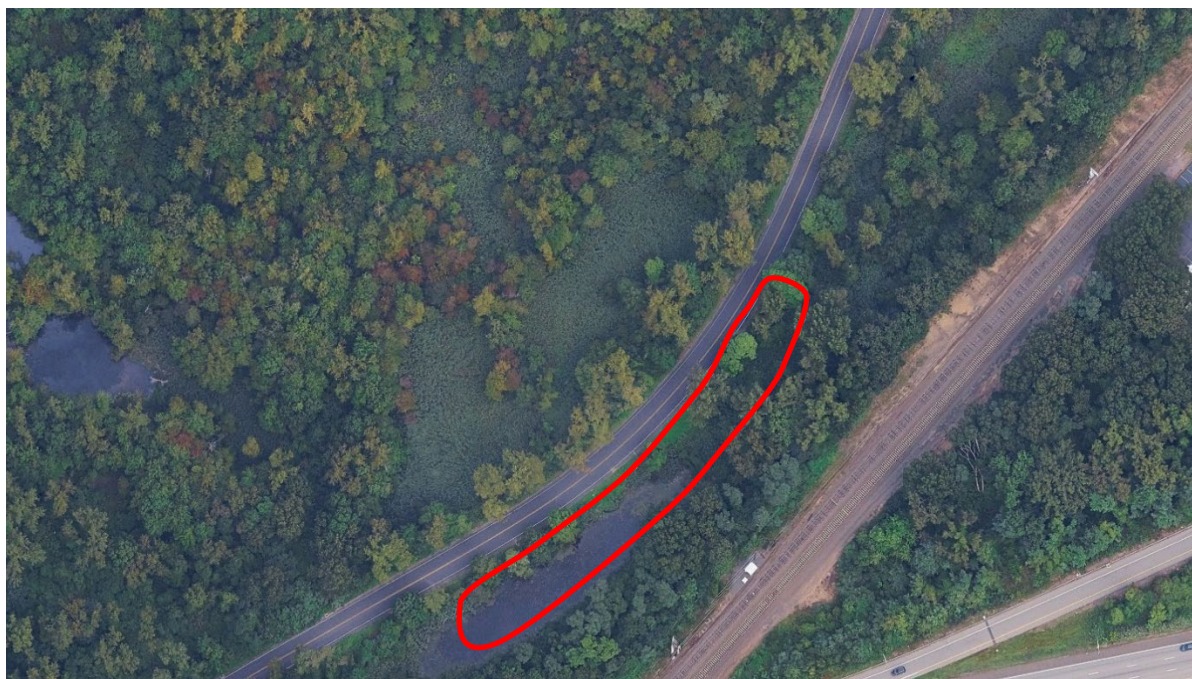
Figure 19
Approximate Location for Additional Chevron Alignment Signage
(Source: Google Earth Pro)

The Town may want to consider installing additional chevron alignment signs around Horizontal Curve #2 in conjunction with installing retroreflective sheeting along the signposts to improve visibility around the entirety of the curve in accordance with MUTCD guidance. Per MUTCD for curves with a posted speed limit between 20 mph and 30 mph, chevron alignment signs are recommended to be spaced 80 feet apart along the entirety of the curve. Horizontal Curve #2, which has a length of 474 feet, is recommended to contain six evenly spaced chevron alignment signs in both directions of travel for a total of 12 signs. The approximate location for the additional signs is shown in **Figure 19**.

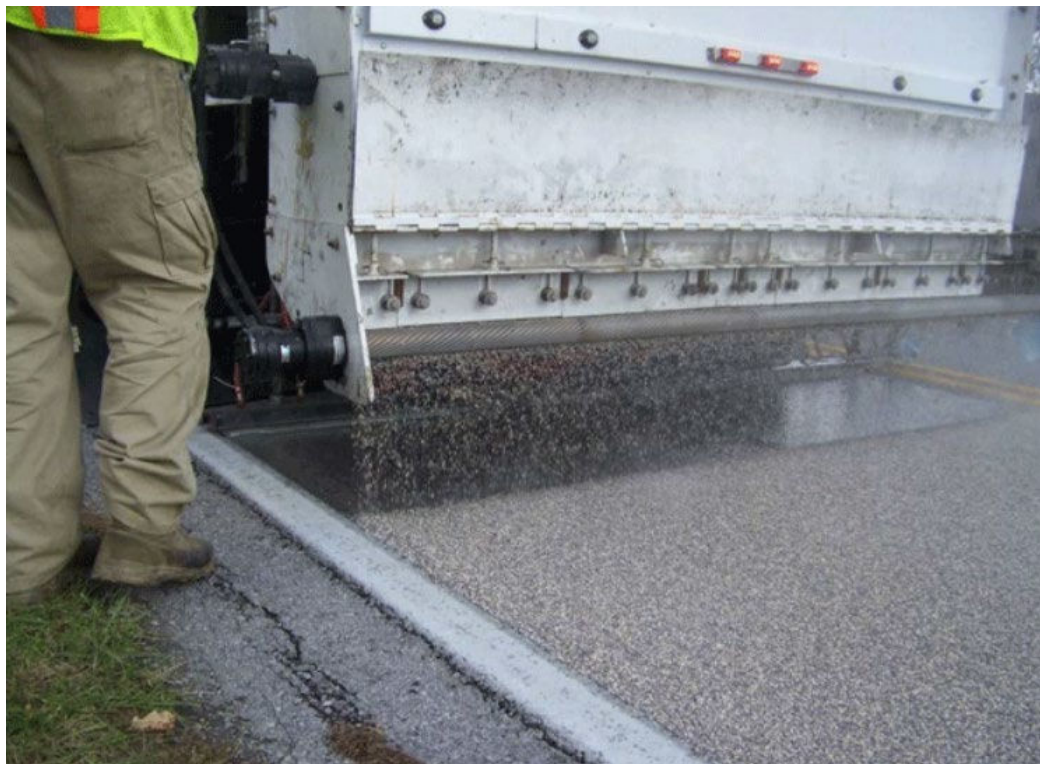
Figure 20
High Friction Surface Treatment Application
(Source: FHWA)

The crash analysis along the Valley Service Road corridor indicated that one-fourth of the crashes occurred in slippery pavement conditions (rain, snow, ice, etc.), with a significant portion of these instances occurring around the two horizontal curves and largely resulted in vehicles running off the road. This is often due to a loss of traction while vehicles brake or steer. It is recommended that the Town of North Haven investigate installing High Friction Surface Treatment (HFST) around the horizontal curves within the Valley Service Road corridor. HFST is a proven safety countermeasure recommended by the FHWA, which involves the application of a thin layer of polymer binder that adheres high-quality aggregate to existing pavement (see **Figure 20**). HFST improves vehicular traction in all weather conditions, and it has been estimated to reduce crashes on slippery pavement by up to 83 percent and the total number of crashes by as much as 57 percent¹.

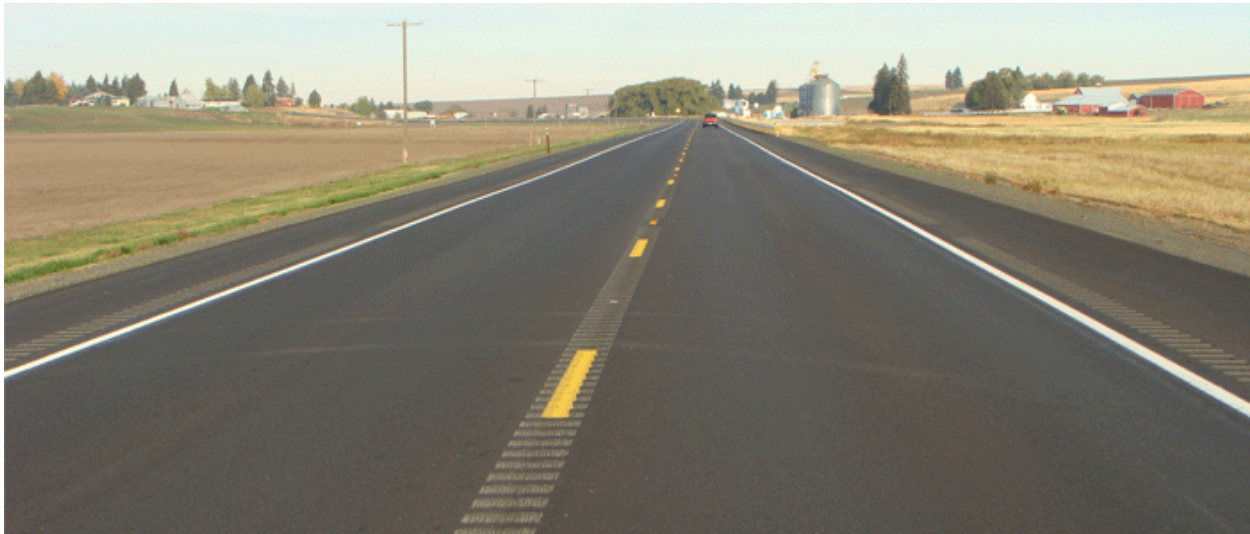
Figure 21
Rumble Strips (Centerline and Shoulder)
(Source: FHWA)

Rumble strips are raised or milled elements of pavement which alert drivers through vibration and sound that their vehicle is leaving the travel lane. Longitudinal rumble strips along the shoulders or centerline (see **Figure 21**) reduce the potential for vehicles running off the road or veering into the opposing travel lane, respectively. Transverse rumble strips may be installed within the travel lane and may be used to reduce motorist speeds. The Town should also investigate the systemic installation of rumble strips along other corridors in the Town which have a significant history of fixed object crashes.

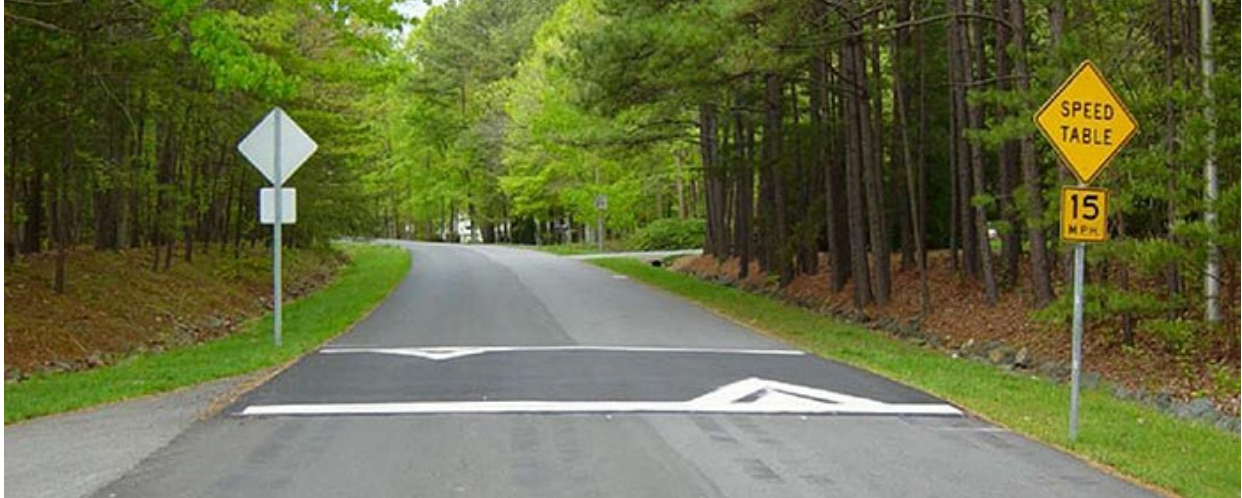
Figure 22
Speed Table
(Source: FHWA)

The Town should evaluate installation of speed tables or speed cushions along the Valley Service Road corridor to reduce operating speeds. Speed tables are slightly raised platforms with tapered ends and flat tops that are elongated to span the entire roadway width. Speed cushions are similar to speed tables but are segmented, typically into three smaller sections, which allows wide enough gaps for emergency vehicles, trucks, and other large vehicles to traverse without being significantly impeded. Examples of speed tables and speed cushions are pictured in **Figure 22** and **Figure 23**, respectively.

Speed tables/cushions reduce operating speeds by creating small vertical deflections that drivers slow down for. In contrast, speed bumps and speed humps create large vertical deflections that are typically more abrupt which causes wear on heavy vehicles, increases driver discomfort, and forces emergency vehicles to slow which delays response times. Due to the presence of heavy vehicles that access the Valley Service Road corridor, it is not recommended to install speed bumps or speed humps along the corridor.

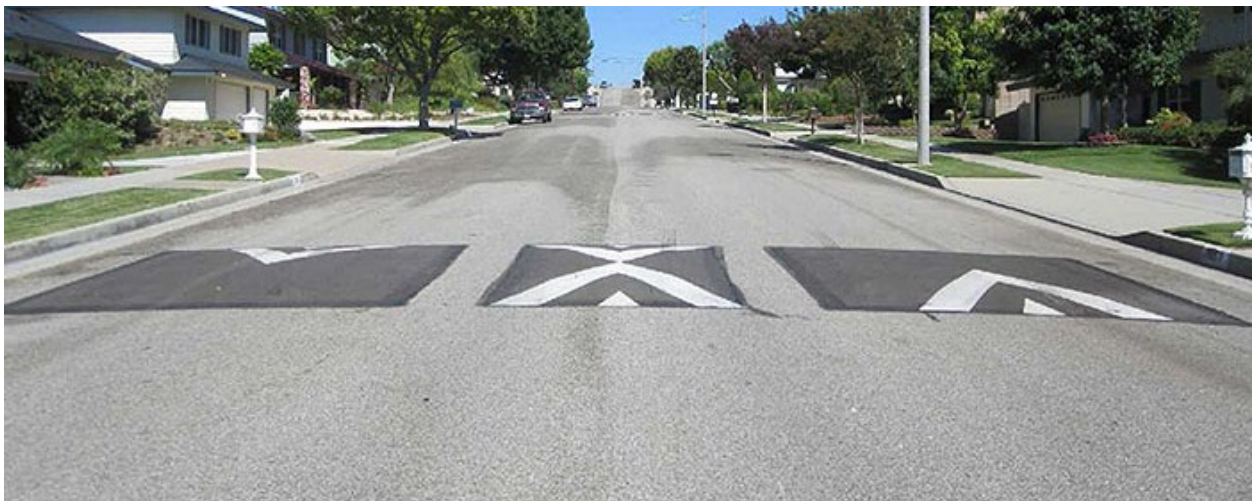
Figure 23
Speed Cushion
(Source: FHWA)

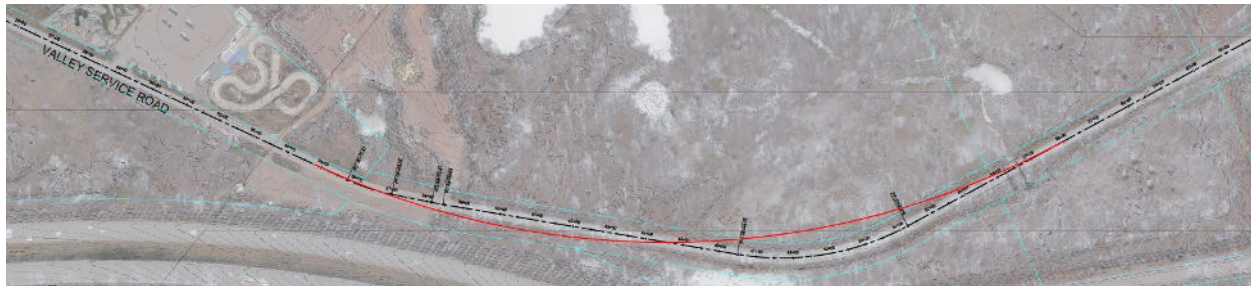
Figure 24
Strategy 1 – Roadway Realignment

This conceptual corridor improvement option proposes to smooth out the successive horizontal curves north of 275 Valley Service Road as illustrated in **Figure 24**. This option would result in a single, longer curve with an easier transition for improved vehicular maneuverability. Travel efficiency should be improved from less frequent braking and steering maneuvers, which especially benefits emergency vehicles, heavy vehicles, or other large vehicles. The consistent geometry of the curve would reduce the number of conflict points along the roadway as well as the potential for vehicles running off the road while improving the sight distance for drivers leading to enhanced reaction times.

This option would require significant reconstruction of the roadway, including relocation of drainage facilities and utilities. Permanent sliver acquisitions of adjacent properties may be required to extend the current right-of-way. Environmental permitting may be necessary as the realignment would require the clearing of trees within potential wetlands areas. The realigned roadway would improve travel efficiency but may increase design speeds, which may encourage speeding if not properly managed with other design measures or sufficient signage.

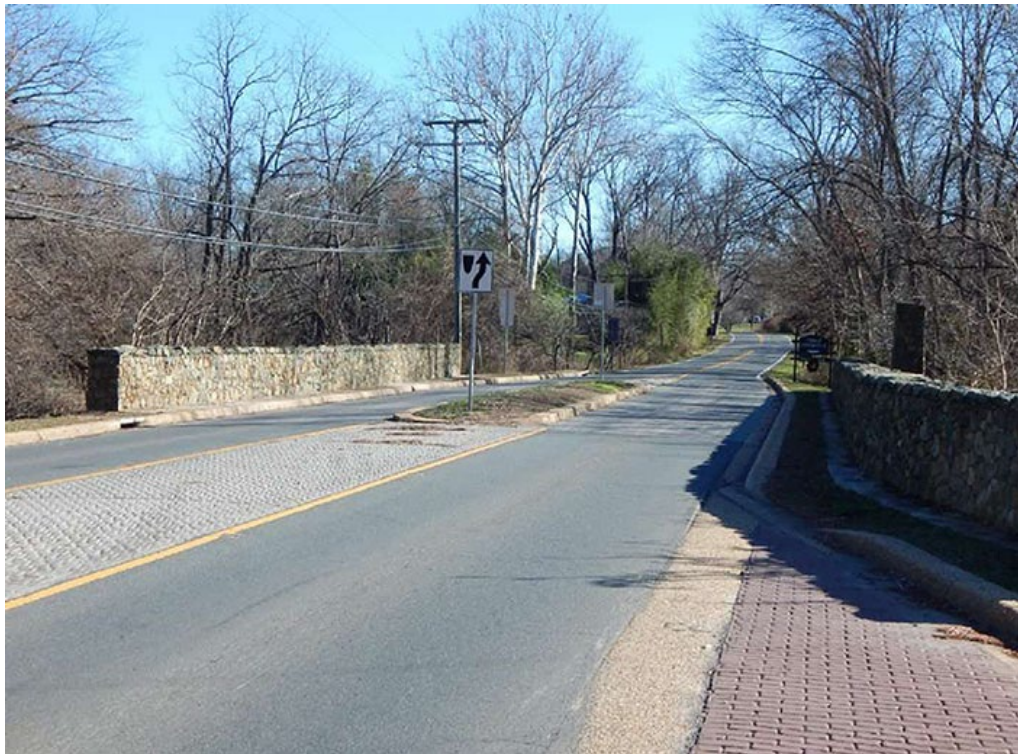
Figure 25
Raised Median Island
(Source: FHWA)

This conceptual corridor improvement option proposes installing median islands along the Valley Service Road corridor. Median islands are FHWA-recommended traffic calming measures intended to encourage lower travel speeds by providing a raised median along the centerline of a roadway to narrow lane widths at that location. Median islands also act as physical barriers between opposing travel lanes to reduce the potential for head on crashes. Median islands vary in design and size, anywhere from a striped area that prevents vehicular use to an island with raised curbs and landscaping that narrow lanes away from the centerline, as depicted in **Figure 25**. Cost estimates were not provided for this strategy given the uncertainty of where the median islands would be installed, however, the average cost of median islands was estimated to be approximately \$500 to \$600 per linear foot. This is assuming a four-foot-wide concrete median with 6-inch curb reveal, two-foot-wide left shoulders, 11-foot-wide lanes, and two-foot-wide right shoulders to fit

within the existing pavement width with no roadway widening. Median islands should be especially considered should the corridor experience commercial, office, or residential redevelopment as they improve mid-block pedestrian safety by providing an area of refuge for crossing pedestrians. Median islands may also be used to limit unsafe or prohibited turning movements and typically fit into the existing right-of-way. Based on Chapter 10 of the CTDOT Highway Design Manual, raised median islands are recommended to have a minimum width of four feet with two-foot shoulders on each side of the island (for a total of eight feet).
