# **Hamden Plains, Wintergreen and East Side Traffic Calming Study**

Hamden, CT

November 2013

Fitzgerald & Halliday Inc.

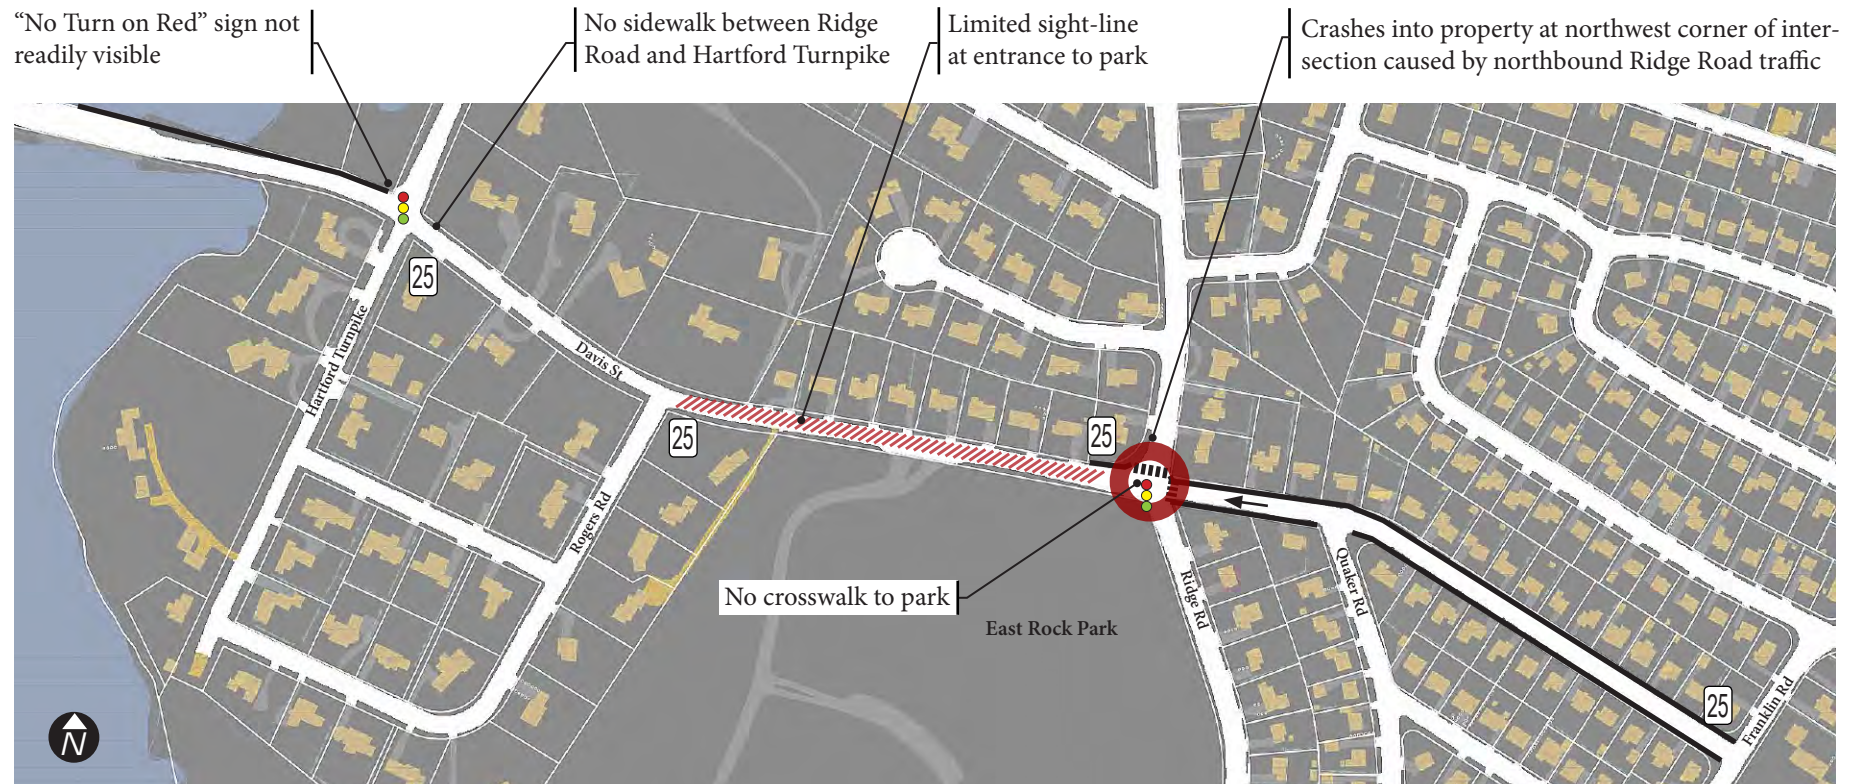
*Limited sight-line on the eastbound approach to the East Rock Park entrance on Davis Street*

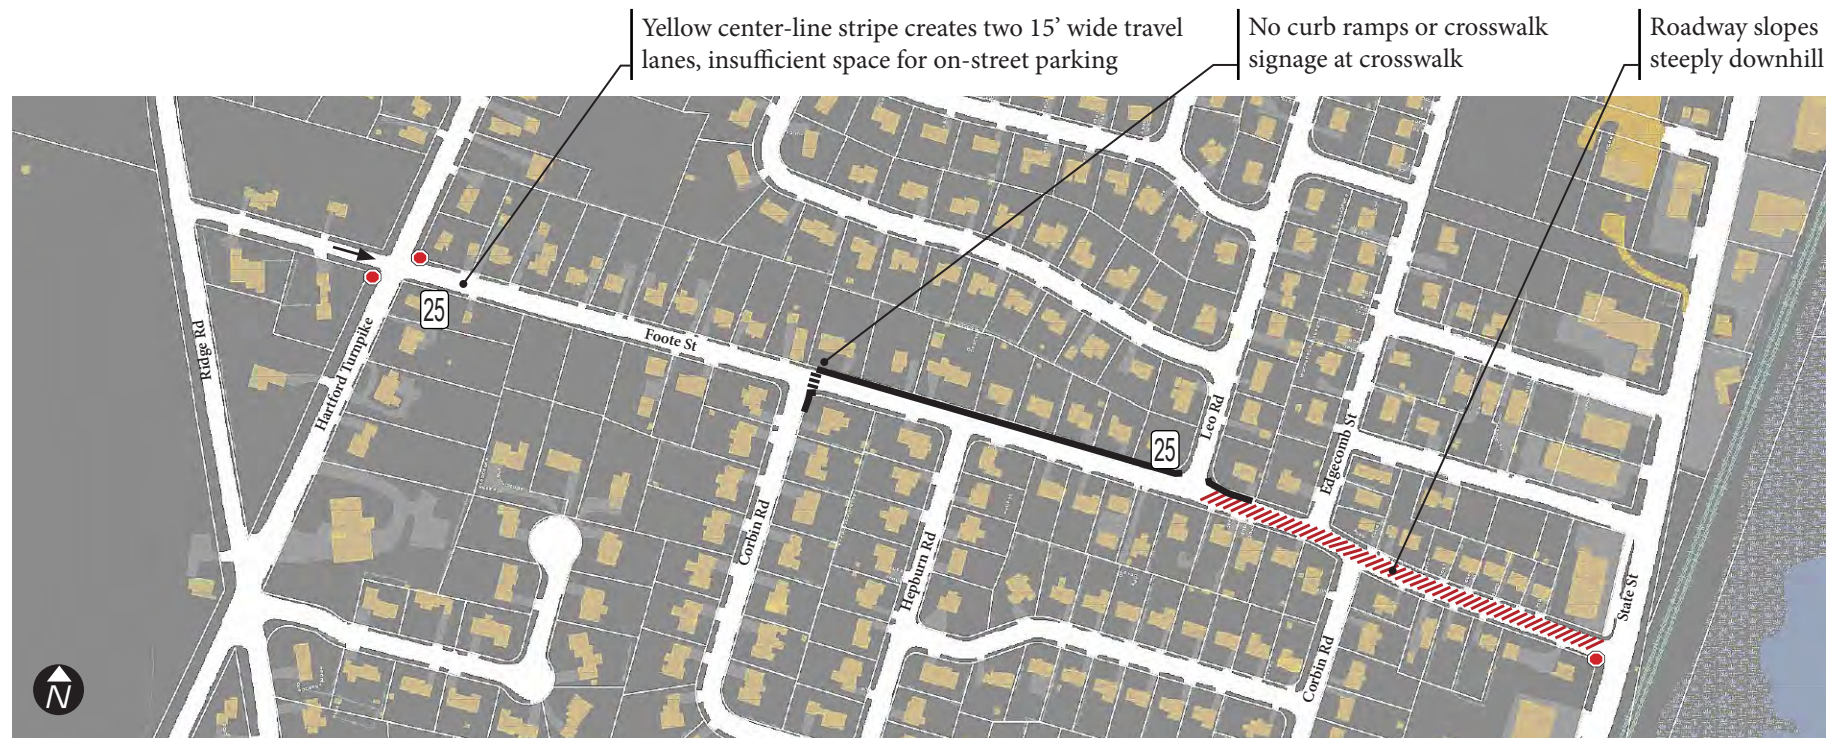
Westbound view looking uphill on Foote Street. School zone crosswalk sign present despite no crosswalk within close proximity.

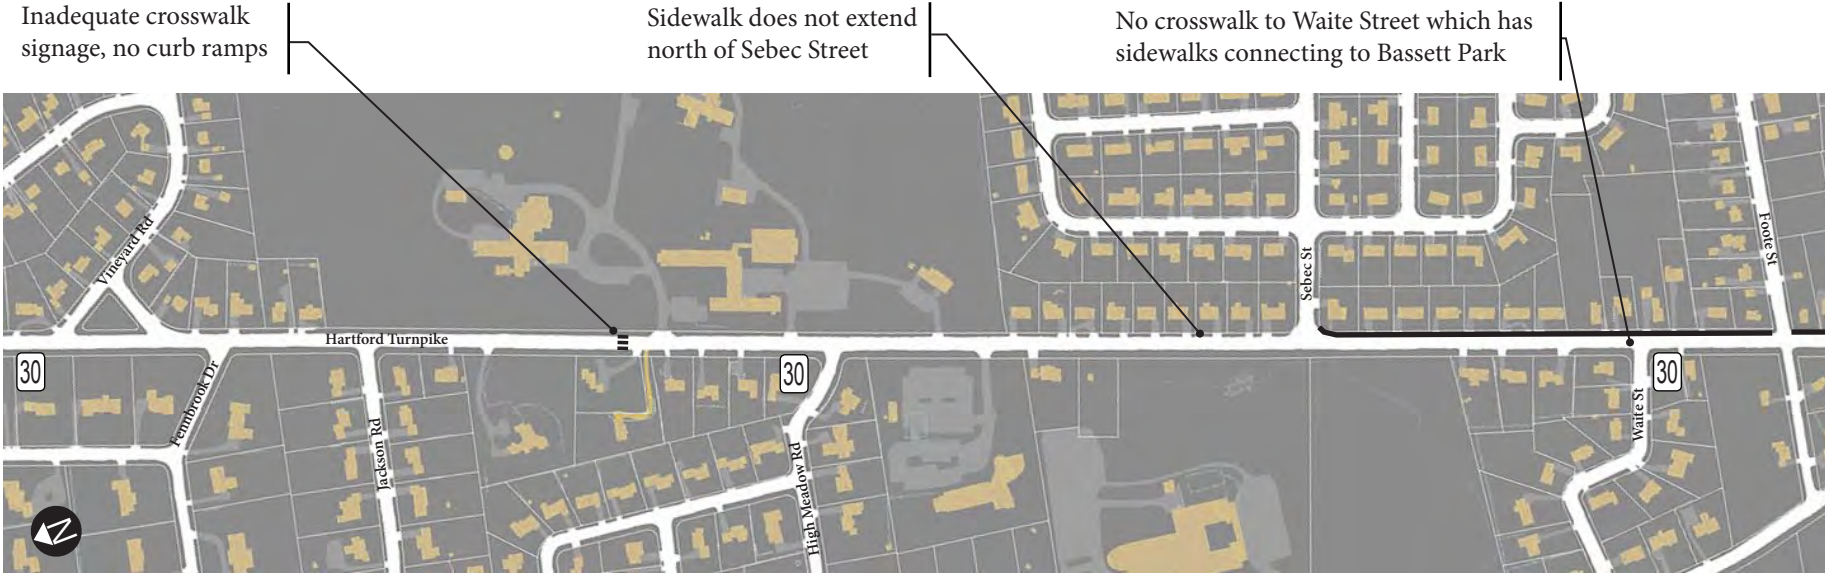
Southbound view near Jackson Road. Crosswalk in distance is barely visible, warning signage is partially obscured by vegetation.

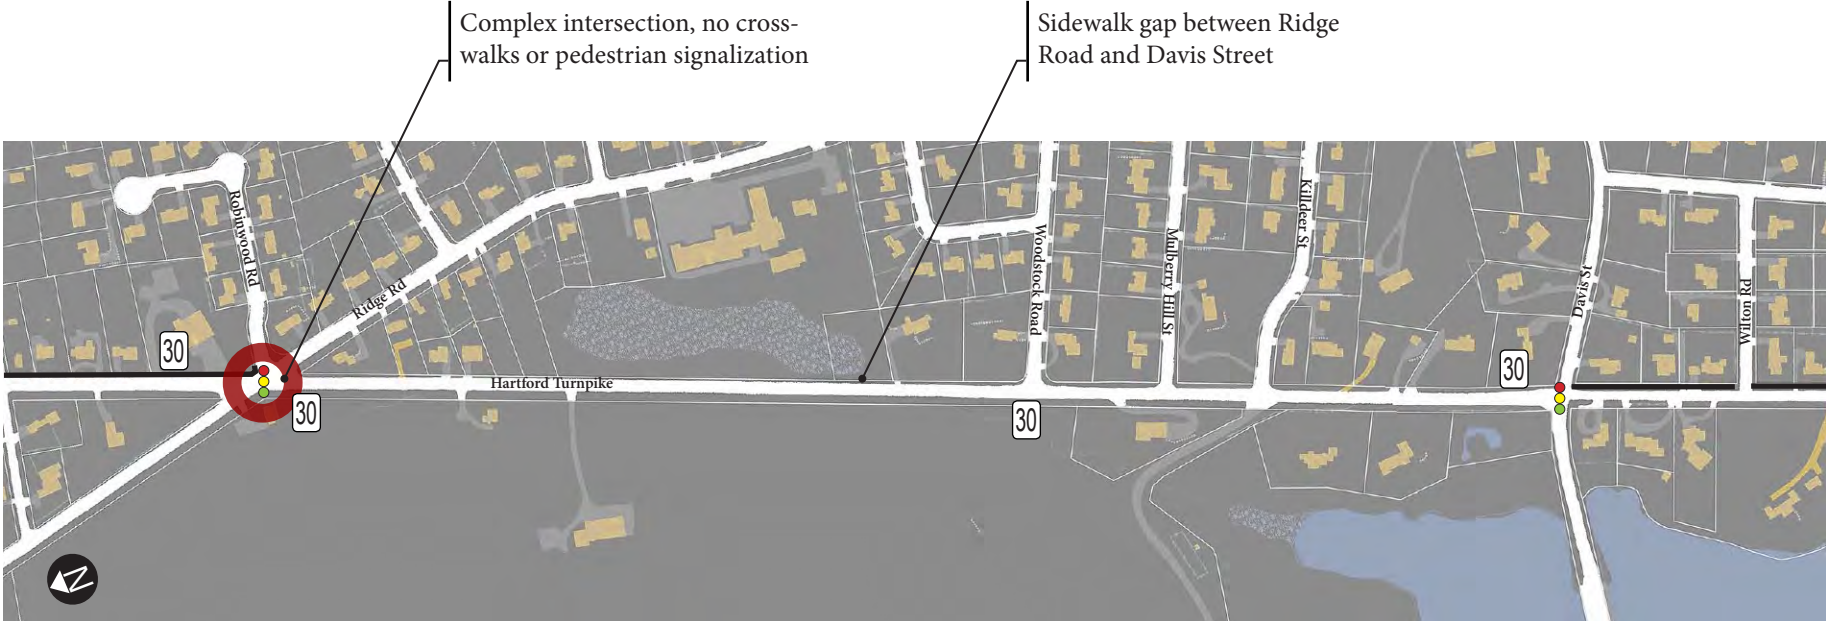
Hartford Turnpike and Ridge Road intersection. Wide intersection without crosswalks despite nearby sidewalks.

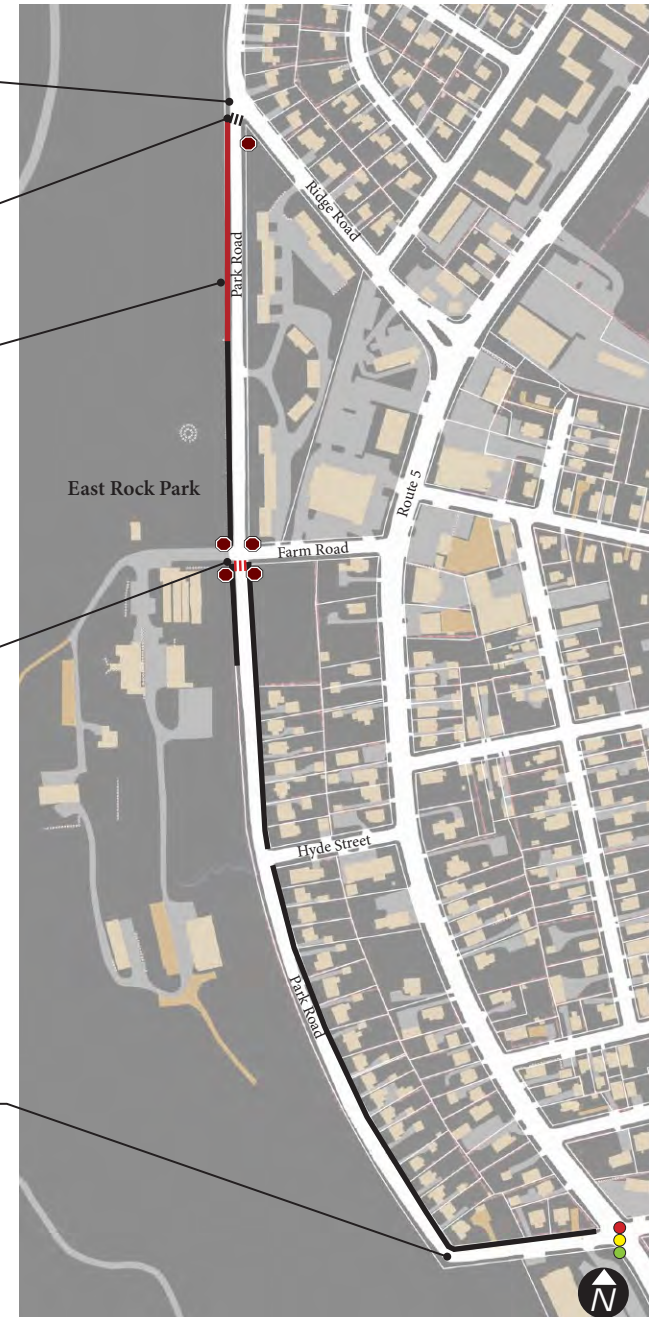
1. Realign curb at Ridge Road
2. Install curb ramps and crosswalk
3. Extend sidewalk to Ridge Road
4. Install curb ramps and crosswalk across Park Road
5. Install new curve warning signage,

Sidewalk construction on Park Road is also recommended as a means of providing a continuous sidewalk network along the entire corridor from State Street to Ridge Road. This would provide a pedestrian connection from Ridge Road to East Rock Park and the Pardee Rose Garden. Limited sidewalk construction would also be necessary on Ridge Road to complete this network. Crosswalk improvements and new crosswalks are also needed at Farm Road and at the Ridge Road intersection upon construction of sidewalks.

New curve warning signage is needed at the southern end of the roadway where crashes, related to the road's curve, have been documented.

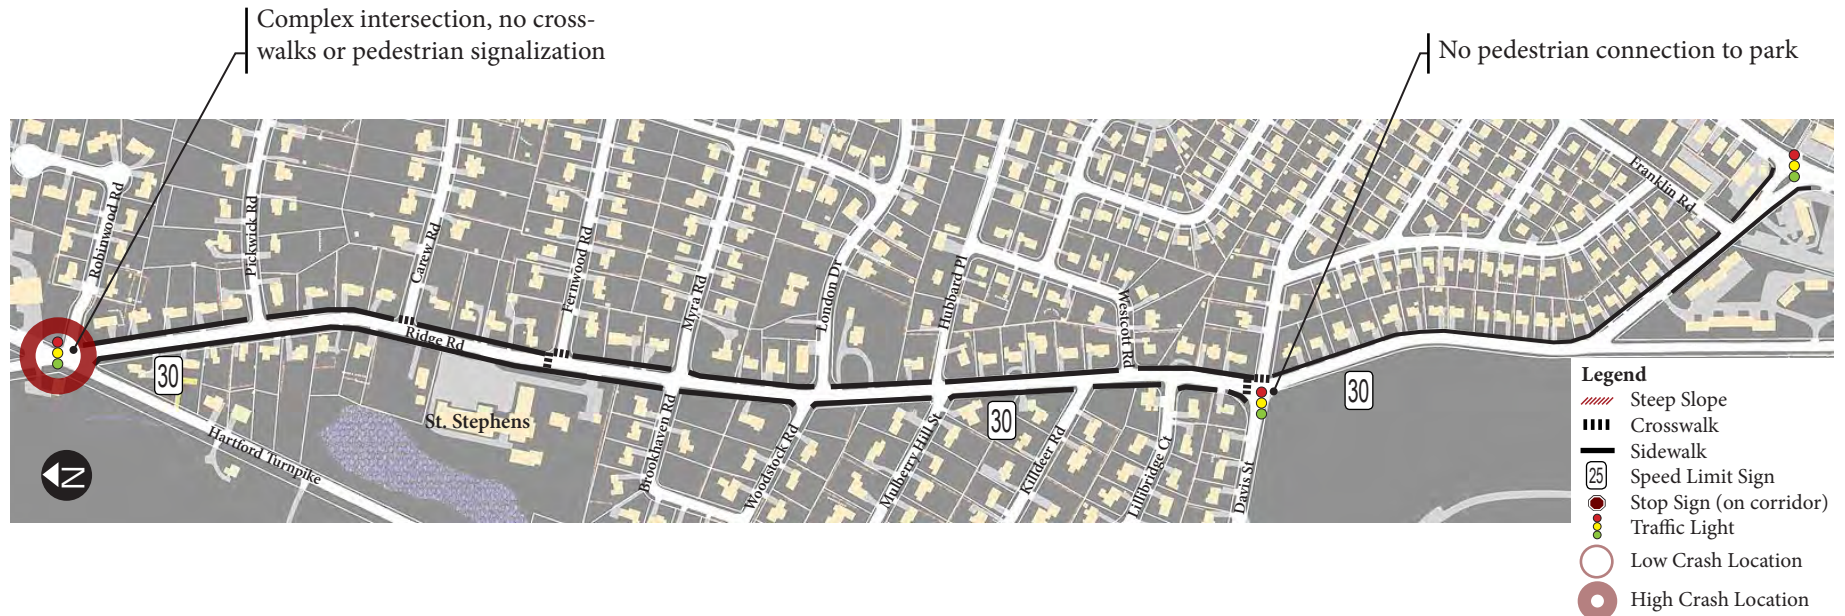
Ridge Road at St. Stephen's Church and School. New crosswalk signage is highly visible.

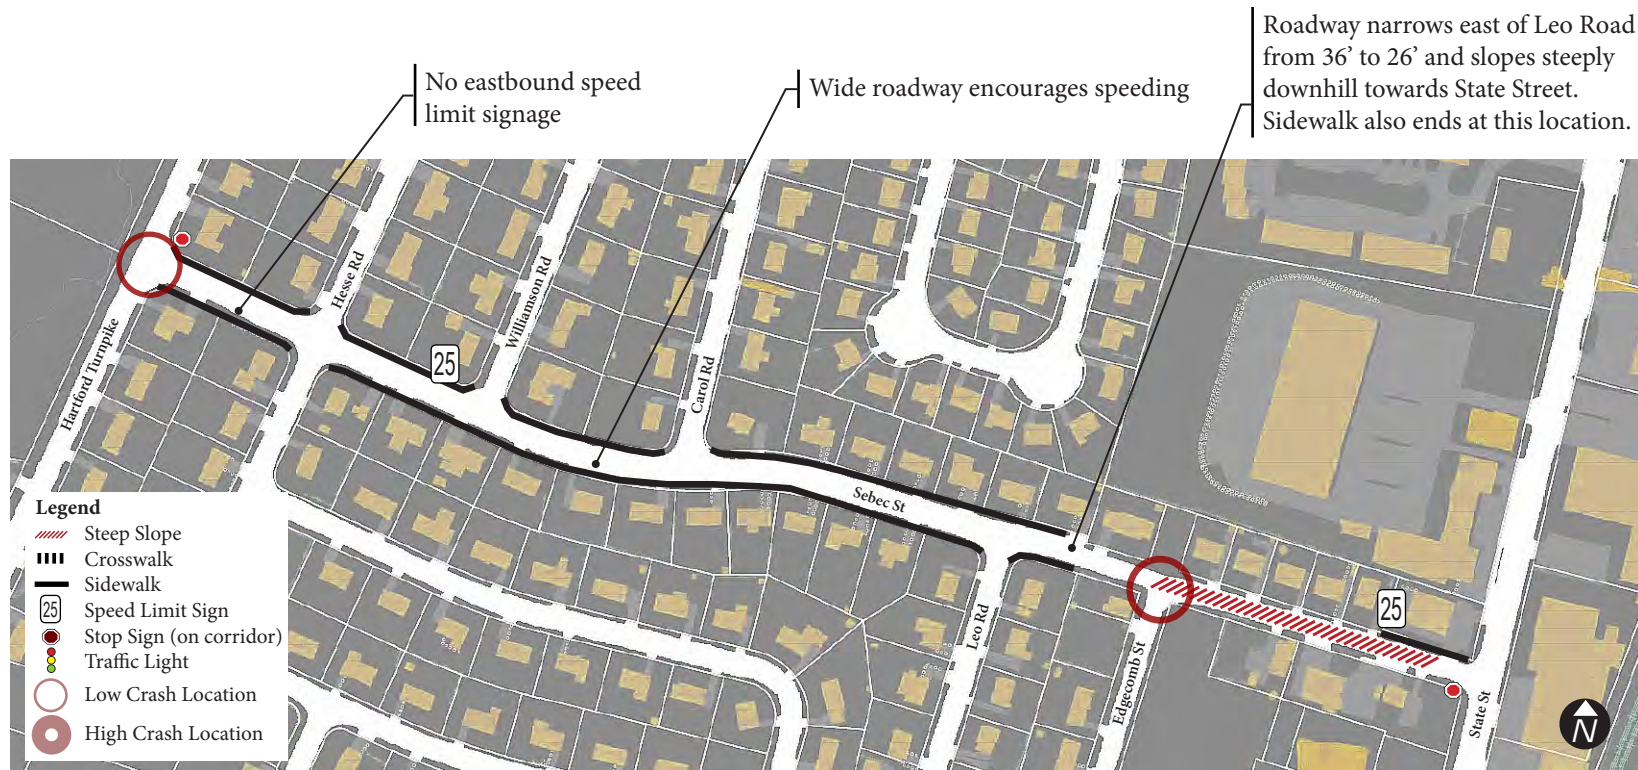
Westbound view on Sebec Street near Leo Road. Roadway narrows before heading downhill on approach to State Street.

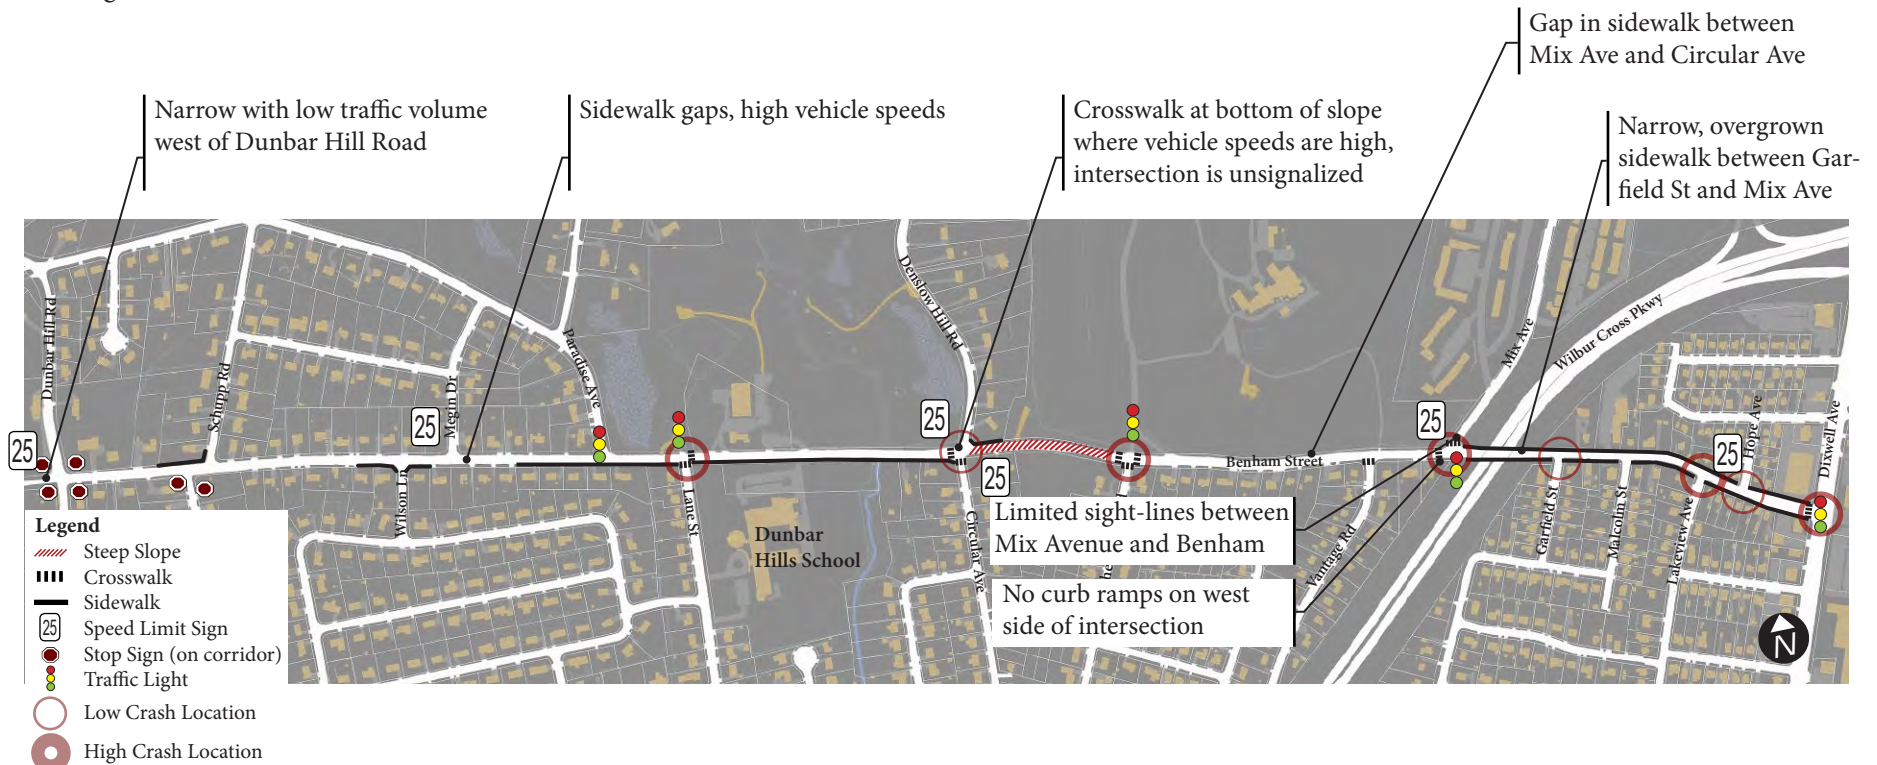
Eastbound view at Denslow Hill Road. Crosswalk is located at the base of a steep hill.

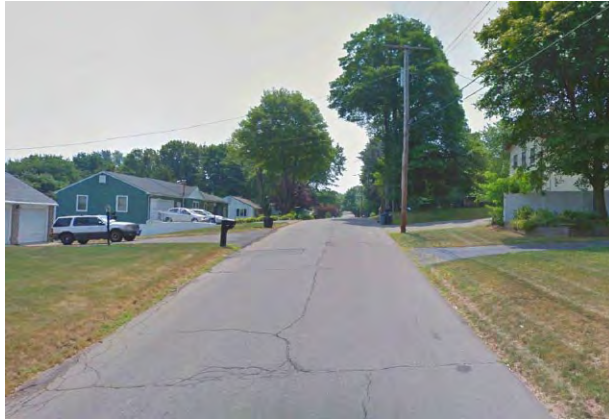
Southbound view of Gilbert Avenue from Benham Street. Roadway is narrow and pavement quality is poor.

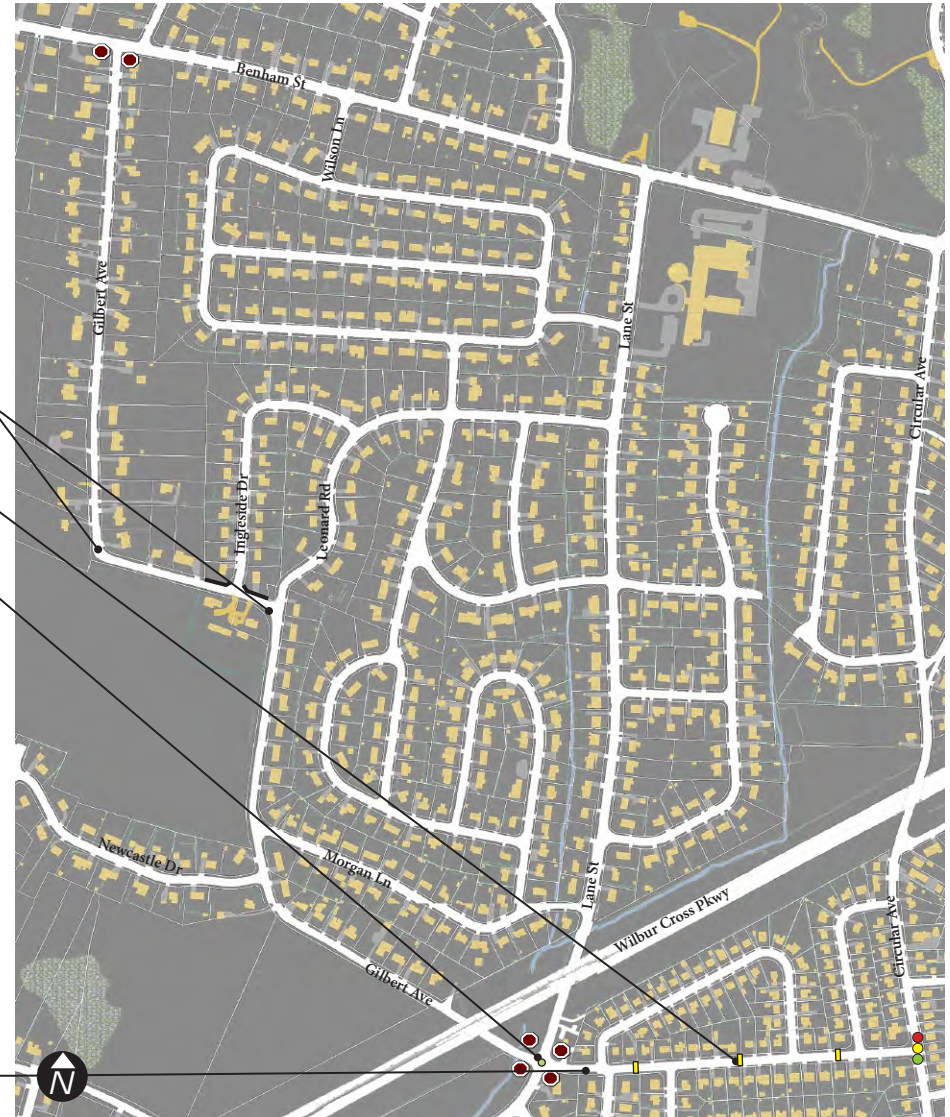
1. Install curve warning signage
2. Install speed humps between Pine Rock Ave and Plains Road
3. Construct traffic circle at Lane St/Brook St intersection

4. Remove yellow centerline marking between Lane/Brook Street and Circular Ave

The recommended improvements for Gilbert Avenue are focused on the segment east of Brook and Lane Streets. This segment has a greater density of homes and more traffic, yet does not have sidewalks. Calming traffic speeds at this segment will improve the safety of pedestrians who walk in the roadway due to the lack of sidewalks. As a low volume local road, speed humps would be the most effective method of calming traffic. The placement of three speed humps between Pine Rock Avenue and Plains Roadway should be considered. Temporary devices should be installed as an interim measure to gauge their effectiveness and the receptiveness of neighboring residents to this measure. Additionally, a traffic circle should be constructed at the intersection with Lane and Brook

Streets. The installation of a circle would prevent stop sign running at this location and mitigate against the collisions that are documented at that location due to failure to stop at the intersection. West of Lane and Brook Streets, new curve warning signage should be installed at two locations where 90 degree curves are present in the roadway.

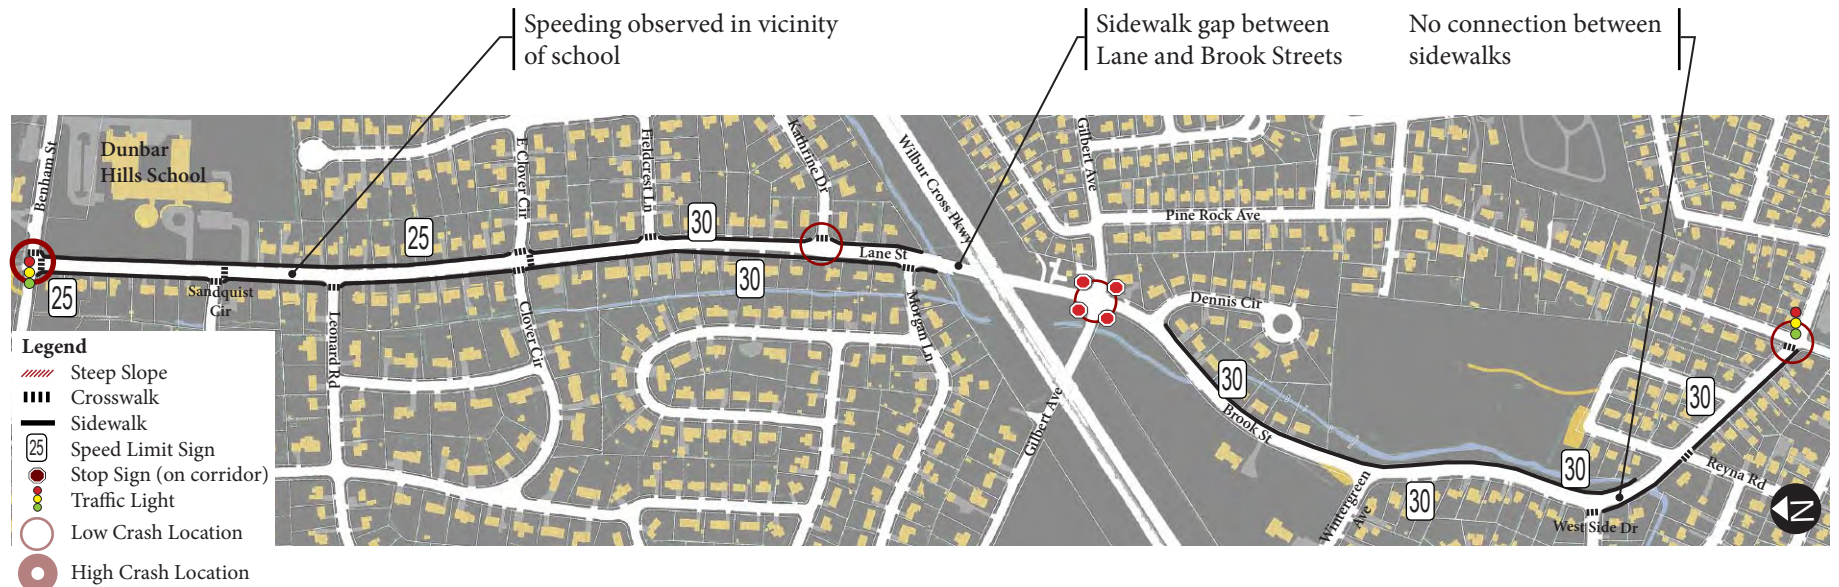
Southbound view of Lane Street approaching the Gilbert Avenue intersection. Stop sign is obscured by trees.

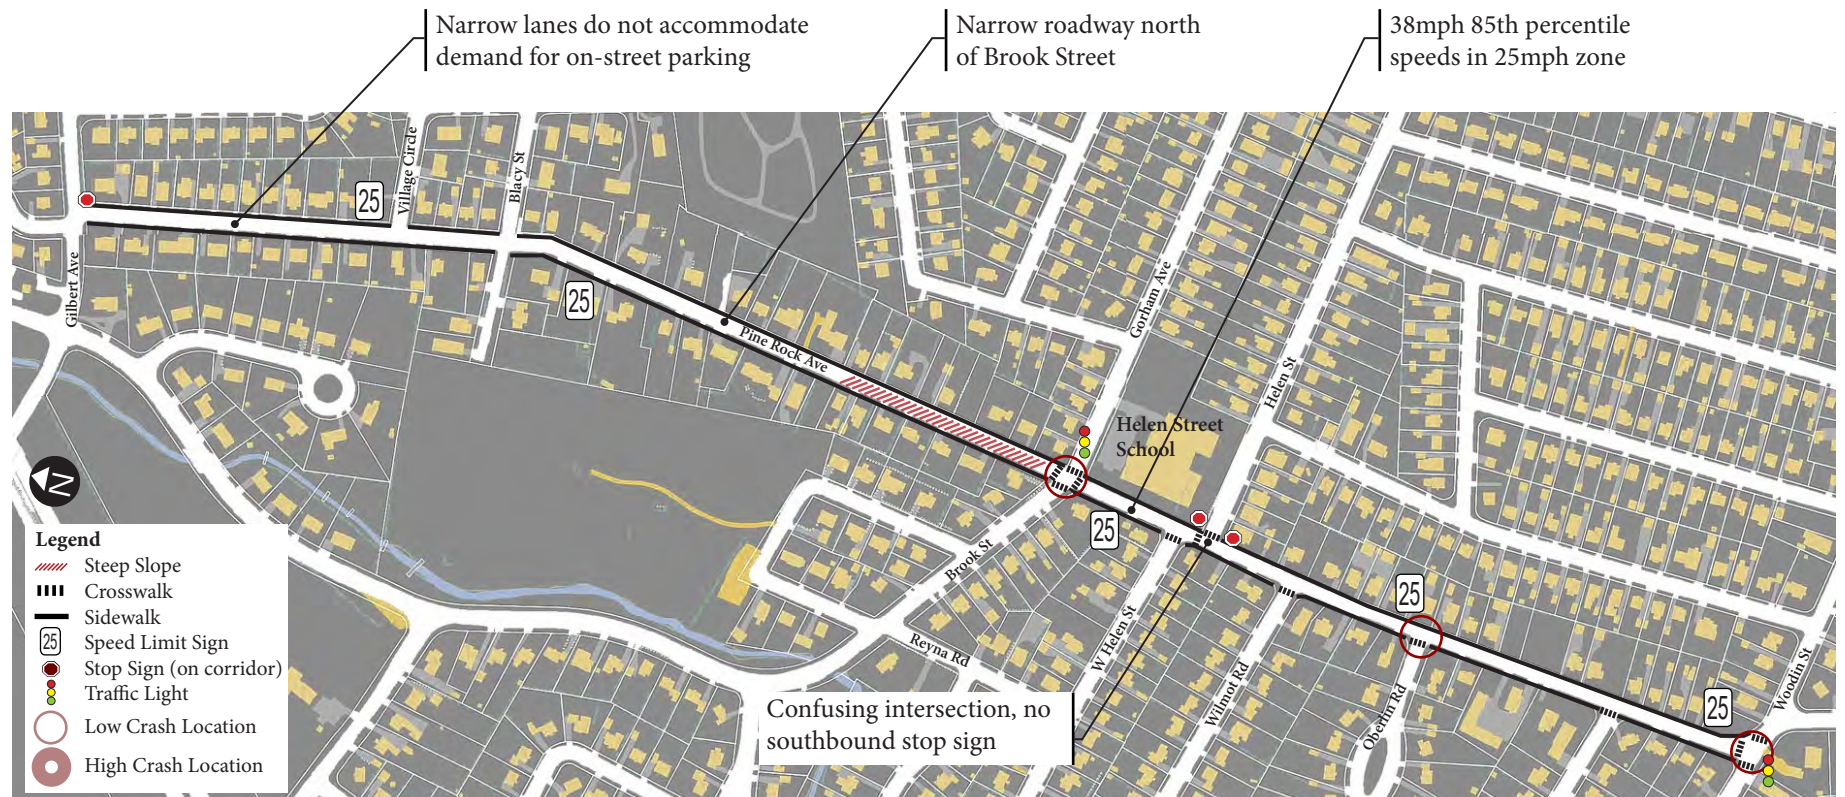
Southbound view on Pine Rock Avenue approaching Helen Street School.

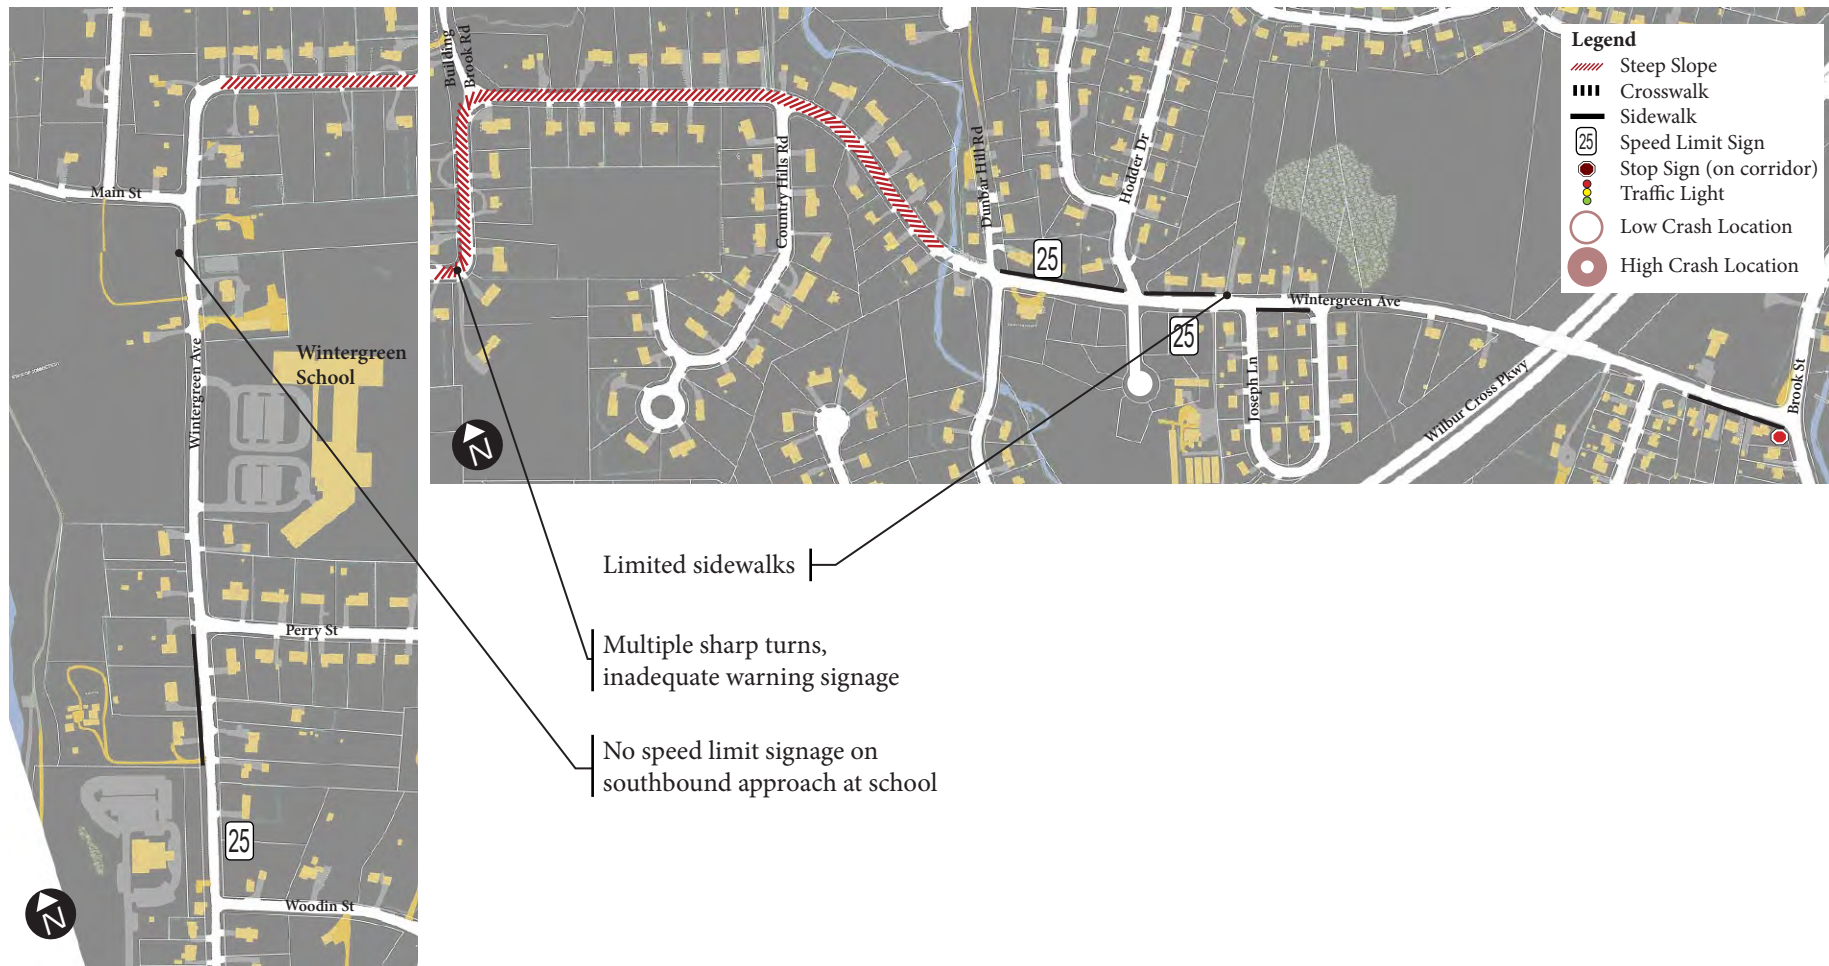
*Sharp turn in roadway, warning signage is inadequate.*

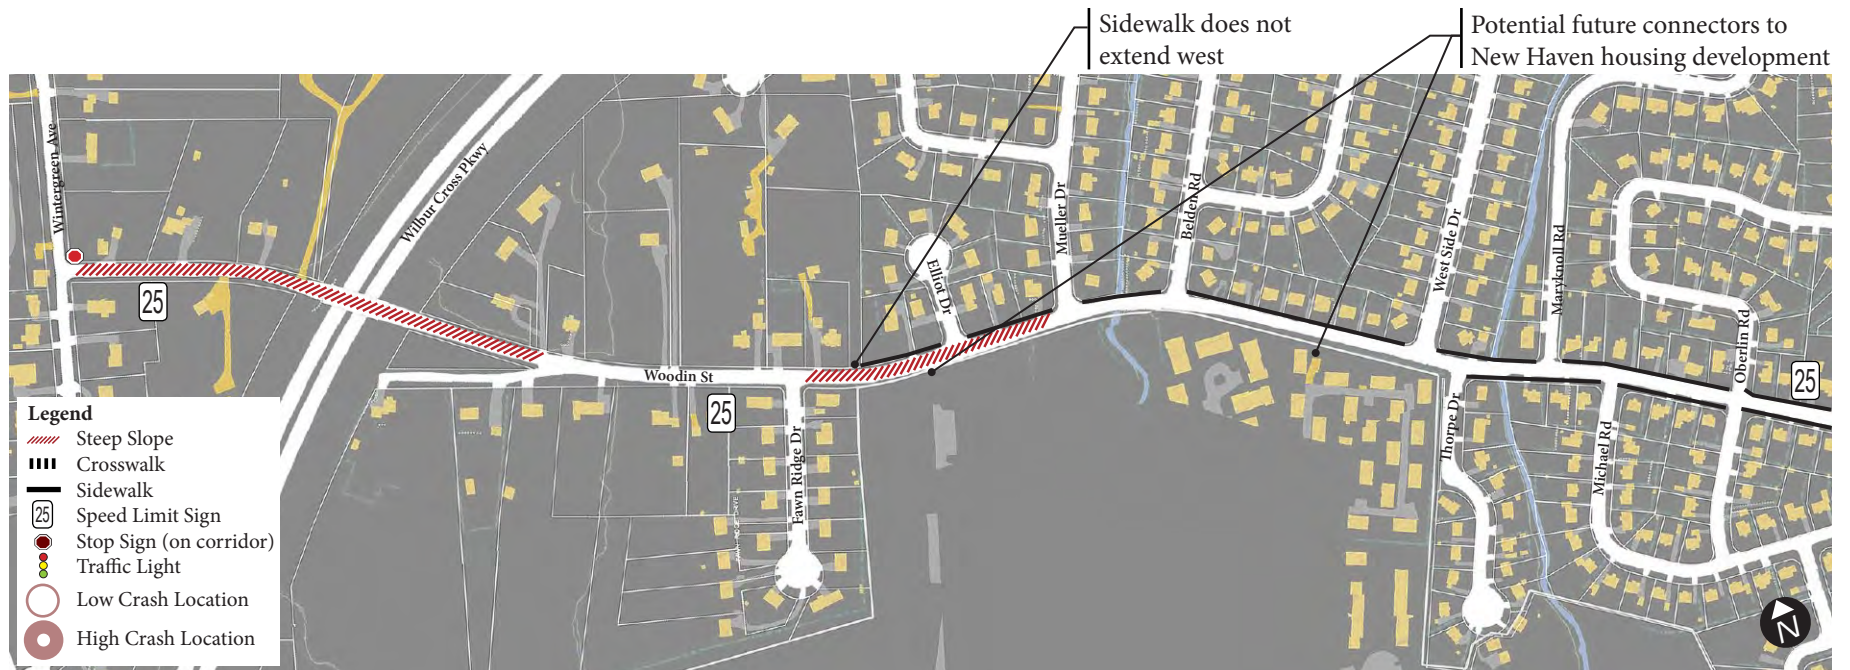
Eastbound view near Fawn Ridge Drive. Sidewalk ends 200' short of several homes on Fawn Ridge Drive.

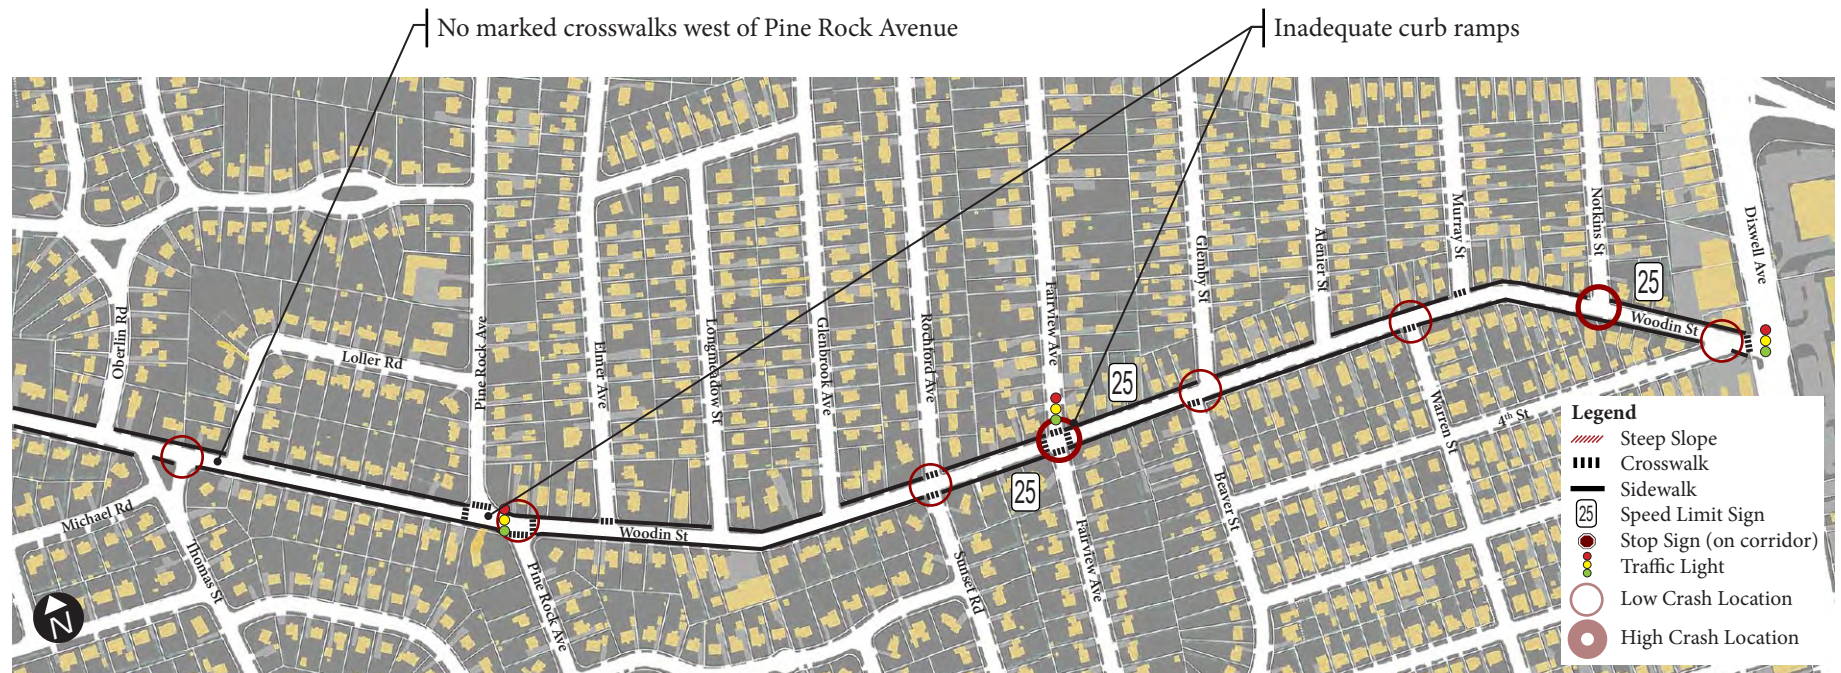
Eastbound view at Pine Rock Avenue. Curb ramps are absent at crosswalks.

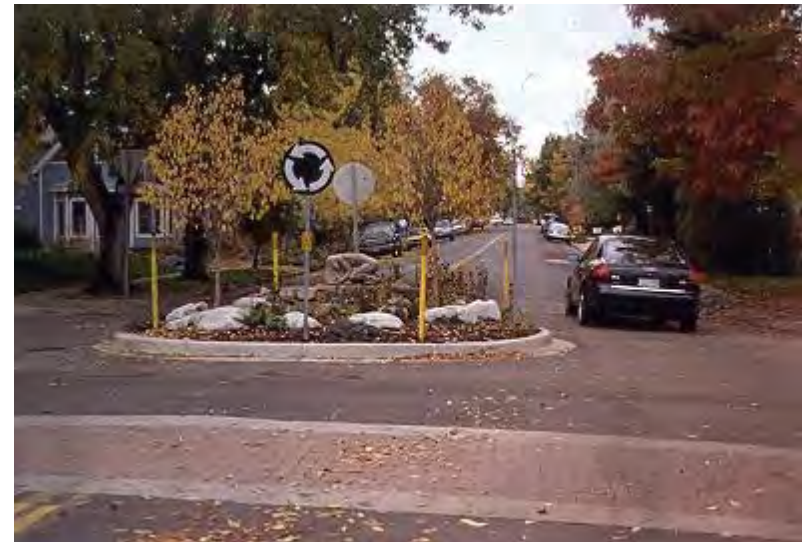
Traffic Circle

- For use on local streets and low volume collector streets
- Replaces four-way stop or low volume signalized intersection
- Landscaping cannot interfere with driver visibility, can be maintained by residents
