City of Meriden Traffic Signal Study

June 2010

Project No. 2009.0603.A10

Location: TL-02 - E. MAIN AND RESEARCH

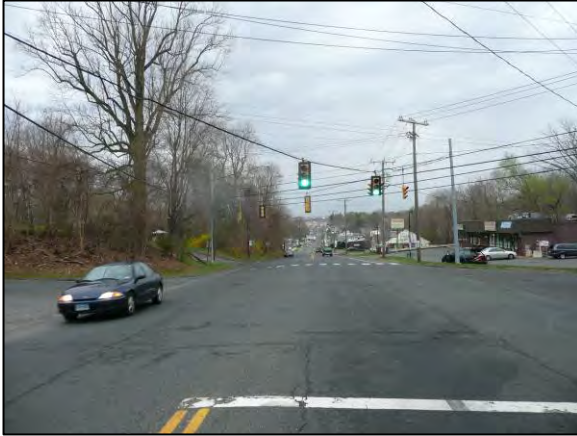
(left) WB on East Main

- Full replacement
- Install no turn on red for NB approach

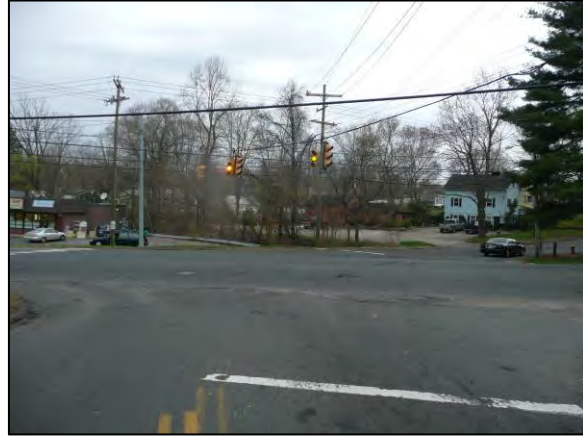
(right) NB on East Main

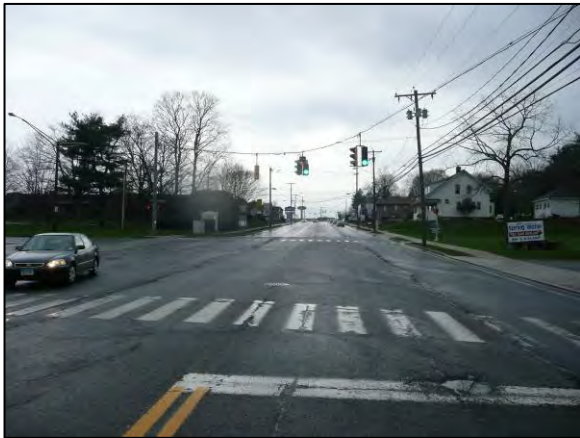
(left) WB East Main and Research

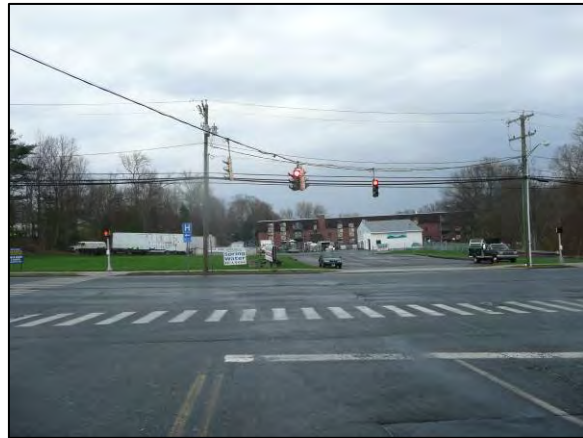
(right) NB East Main and Research

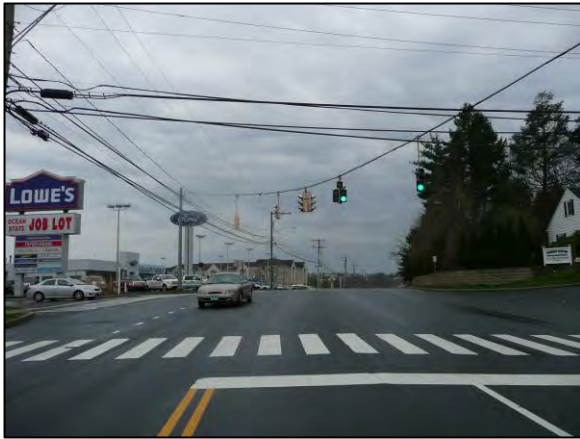
(left) WB East Main and Maple

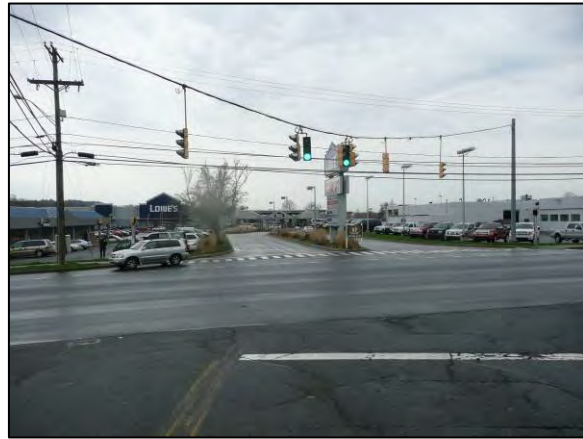
(right) SB East Main and Maple

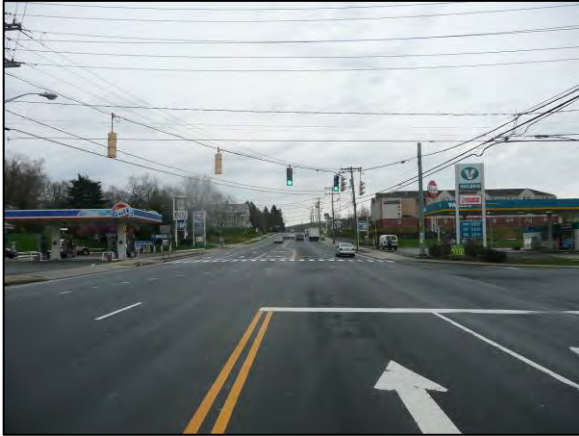
(left) EB East Main and Pomeroy

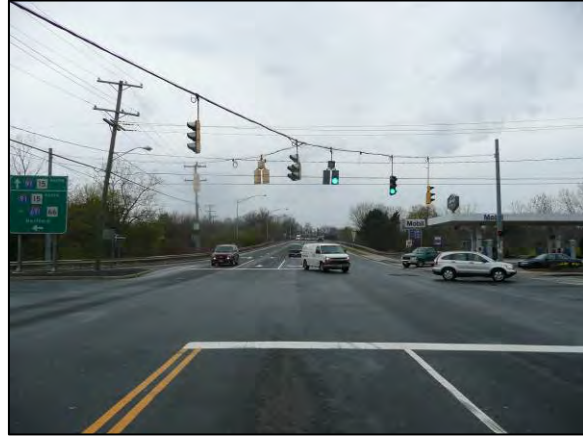
(right) NB East Main and Bee

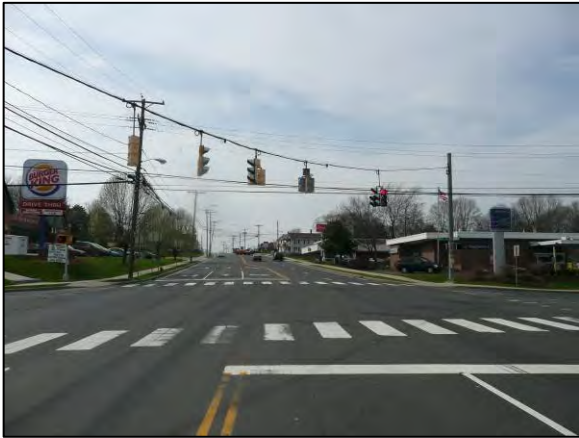
(left) WB East Main

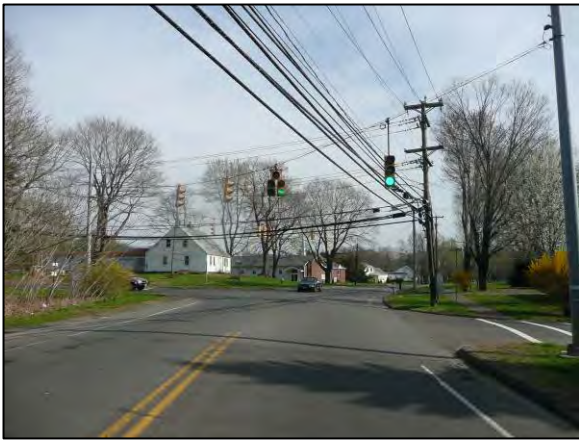
(left) NB on Paddock

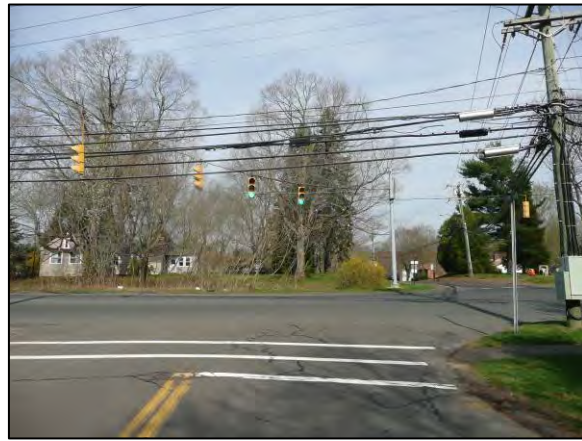
(right) EB on Miller

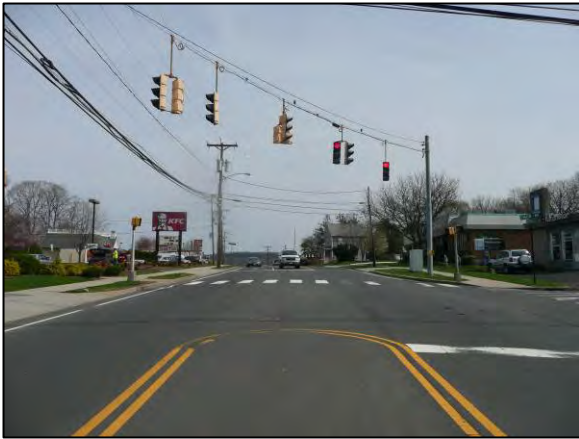
(left) EB East Main and Swain

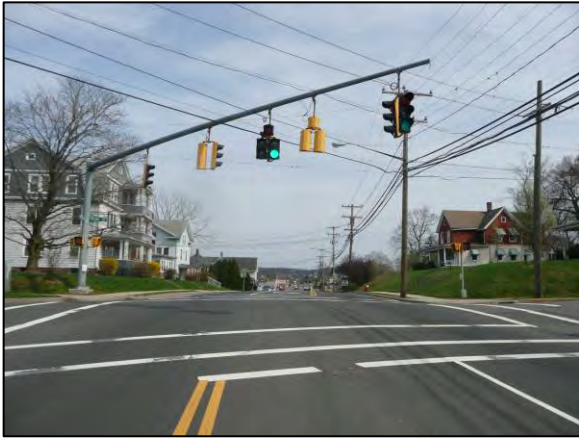
(left) EB East Main

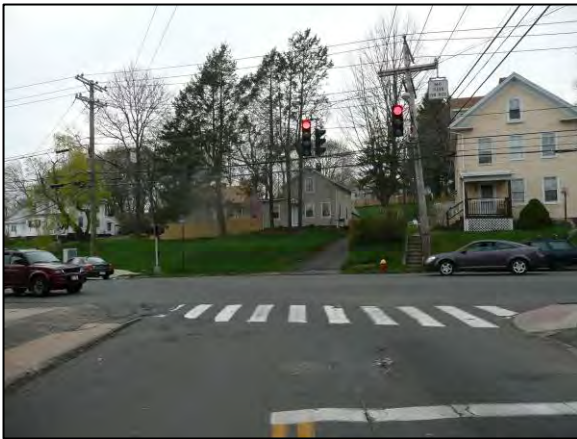
(left) WB Broad and Gale

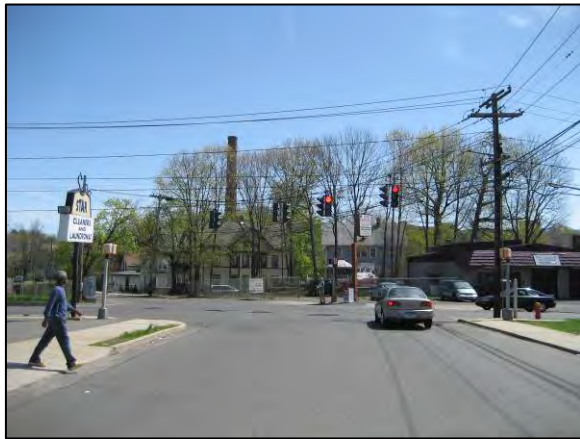
(left) Center and Camp EB

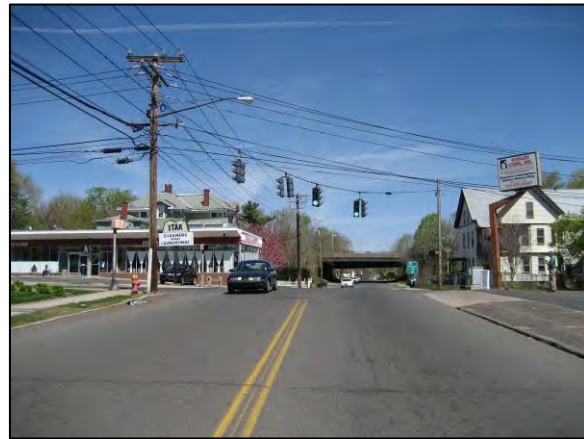
(right) center and Camp NB

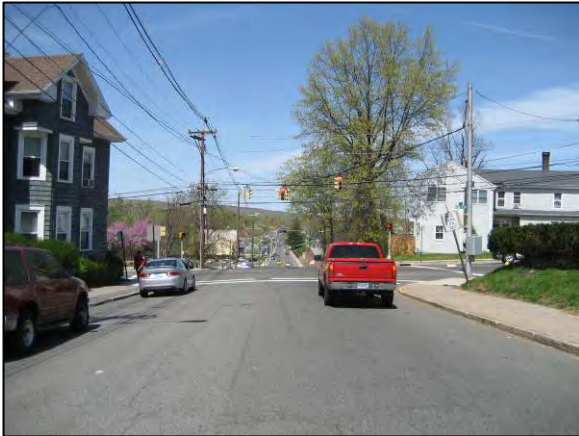
(left) Liberty St and Center St NB

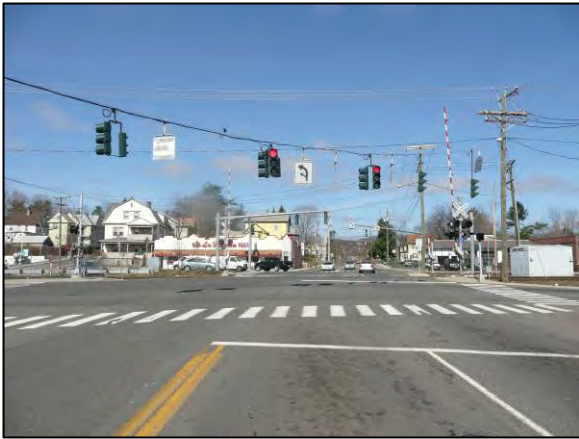
(left) WB Center and Britannia

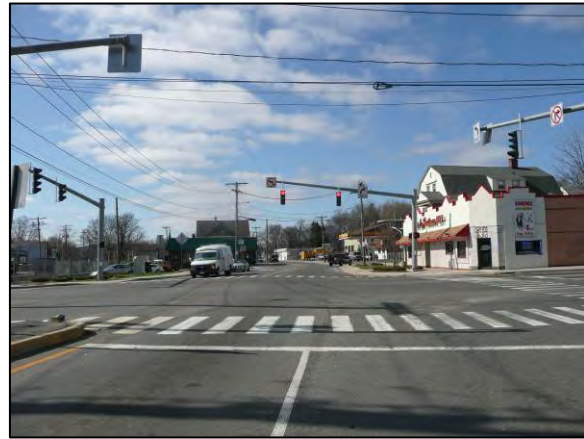
(right) SB Colony and Kensington

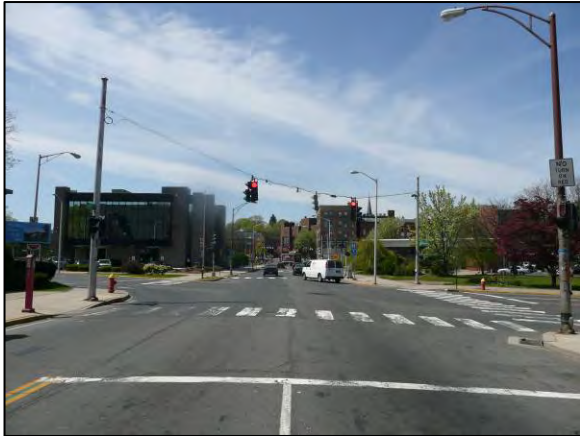
(left) NWB on East Main

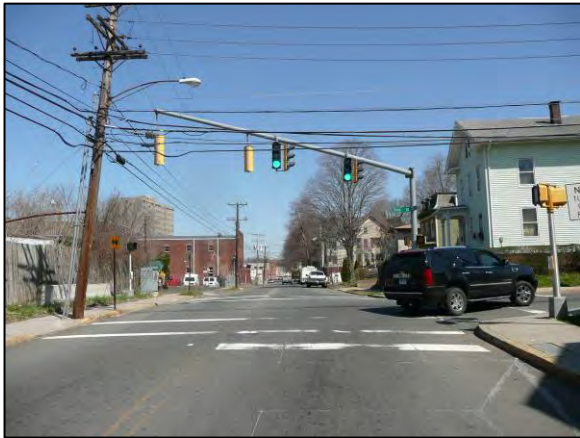
(left) NB Olive and South Colony

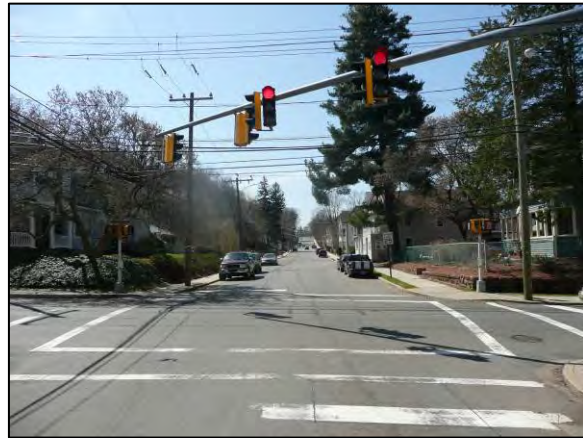
(right) SB Olive and Crown

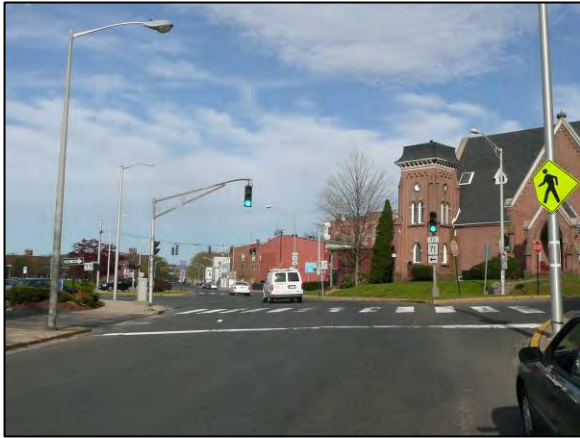
The existing pedestrian signal at the intersection of Perkins Street and Crown Street is in poor condition and is rarely used. During the site visit, it was observed that the pedestrians crossing the roadway at this location frequently do not use the push button, rather choosing to cross during a gap in through traffic. Therefore, the City could consider removing the aging traffic signal concurrent with making improvements to the existing pedestrian crossing. Consider expanding the pedestrian refuge island to the south, which would reduce the crosswalk length from 66 feet to approximately 26 feet and 15 feet.

(left) EB on Perkins

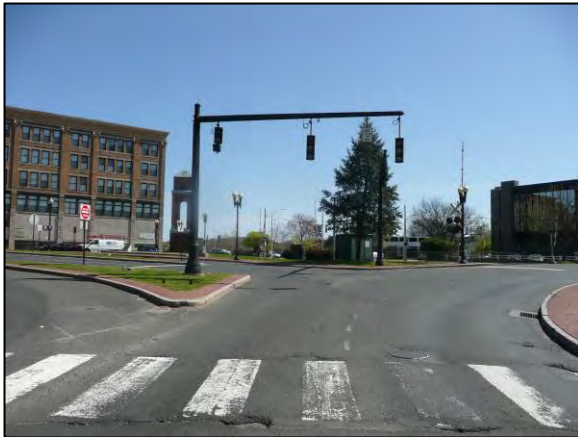
(left) EB on Hanover

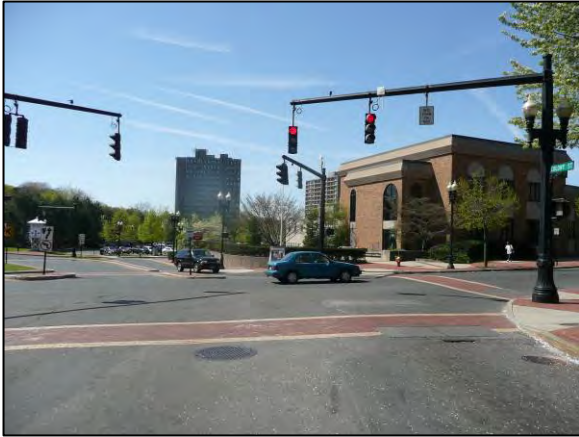
(left) SB on Colony at West Main

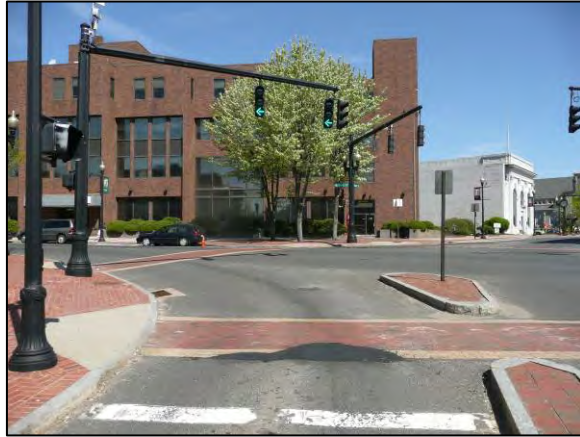
(right) NB West Main and Colony

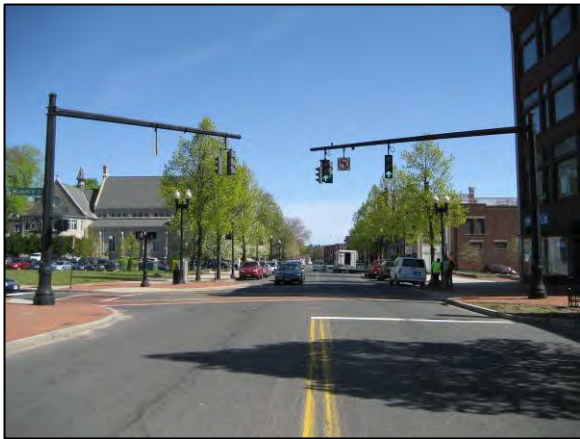
(left) Colony and Church EB

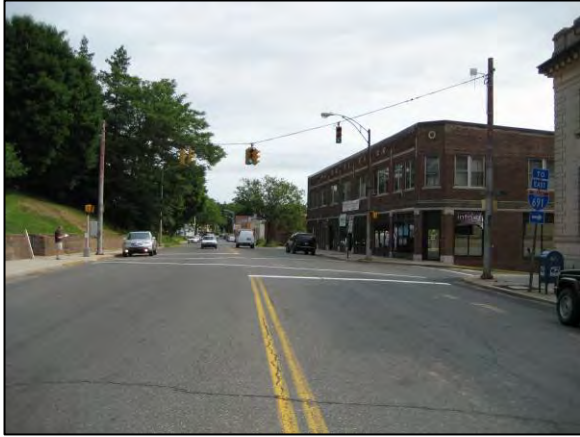
(left) Colony and Brooks NB

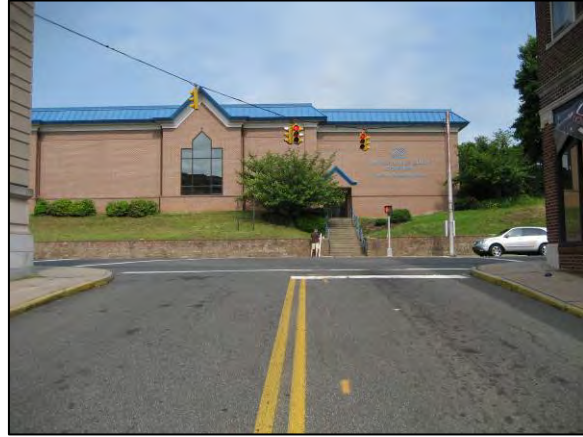
(right) Colony and Brooks WB

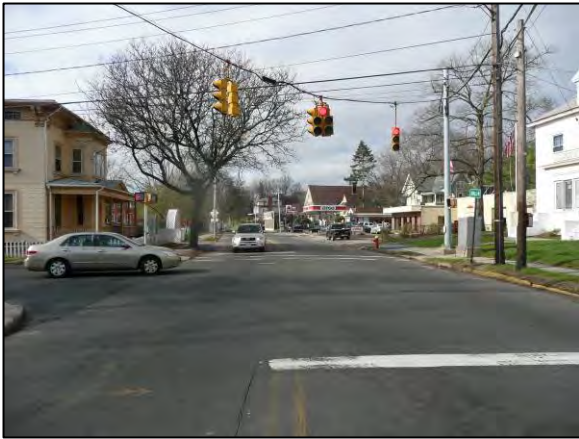
(left) SB Colony and Camp

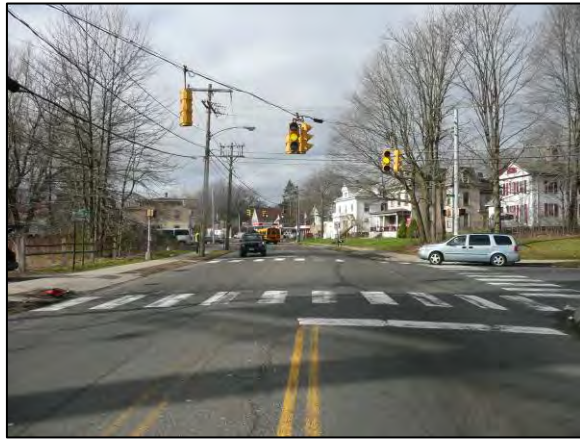
(right) SB Colony and Columbia

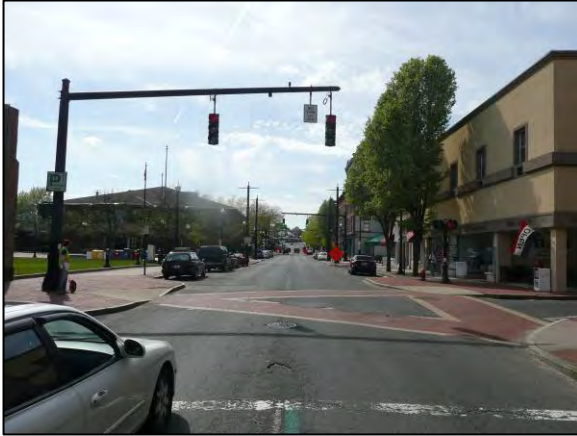
(left) WB on West Main

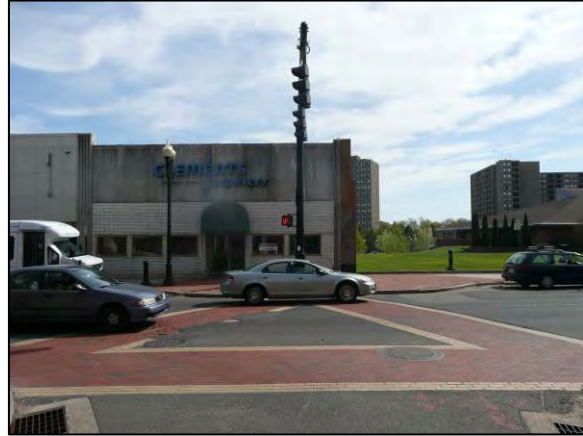
(right) SB on Barristers

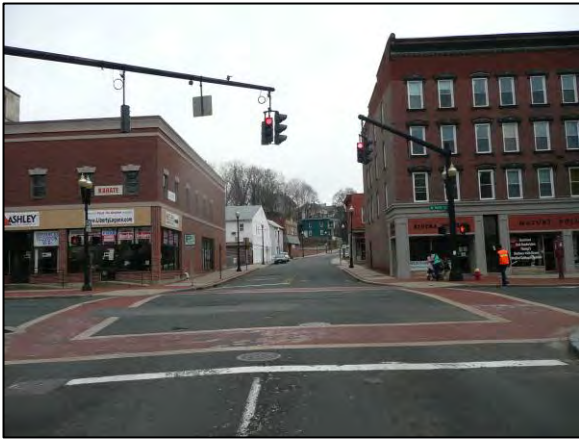
(left) NB on Grove St.

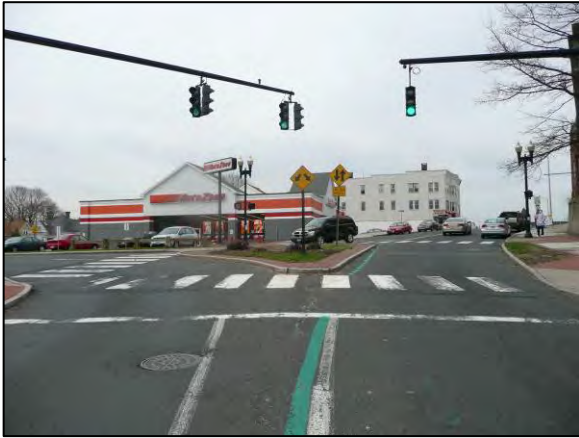
(left) WB on West Main

Fuss & O'Neill recommends that the existing crosswalks at the intersection of West Main Street at Cook Avenue be relocated to use the existing intersection island as a refuge island. This will allow pedestrians to cross a single lane at a time. This improvement will require the partial removal of the landscaping within the island, installation of four new pedestrian ramps, removal of two existing pedestrian ramps, and removal of the traffic signal.

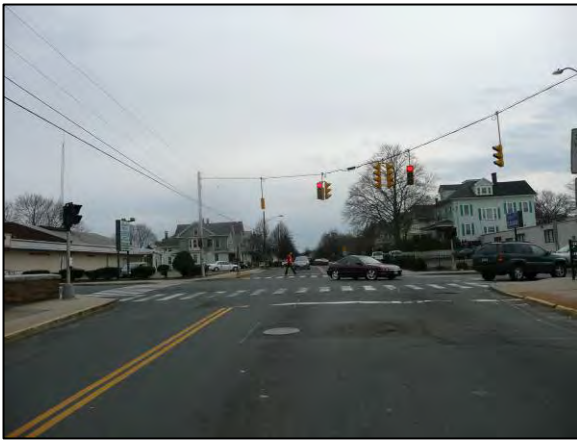
(left) SB to Linsley

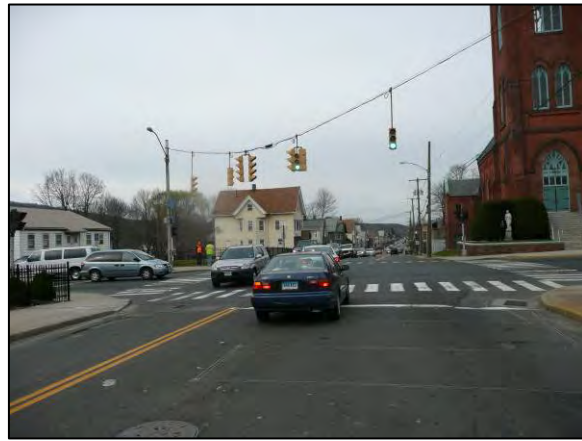
(right) NB to Lewis

- Missing one pedestrian head
- Outdated pedestrian heads
- EB/WB advance phase with bi-color arrows
- No advance clearance time provided
- No lane lines or arrows on NB/SB approaches
- EB/WB Left turn phases called together
- NB vehicle heads too close to stop bar

- Replace all ped equipment
- Provide two lanes on NB/SB app
- Provide clearance time for left turn advance
- Seperate detection for EB/WB left turn phases
- Install WB lane use sign
- Relocate NB stop bar
- Consider full replacement

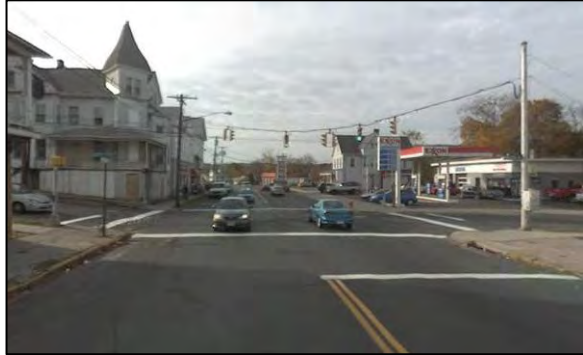
(left) West Main and Windsor WB

Notes
 Signal equipment in fair condition
 Pedestrian heads out of date
 No pavement markings on North Third Street
 Only one pedestrian head per corner
 8" signal faces
 Insufficient vertical clearance
 Unable to open cabinet

Recommendations Full replacement

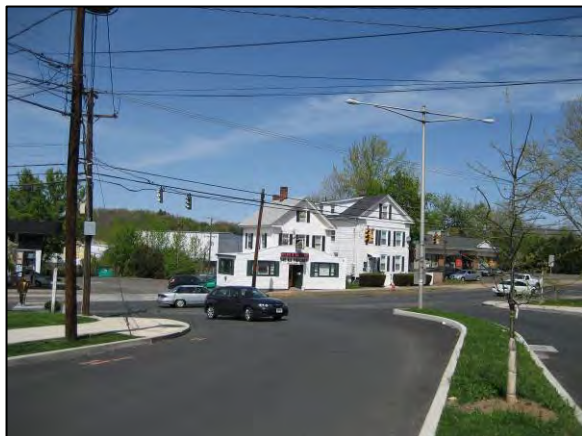
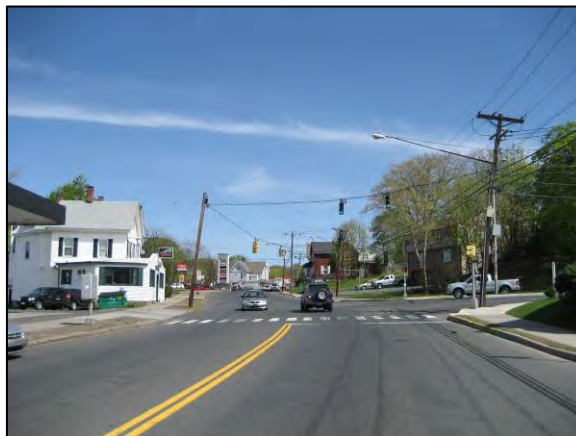
Location: TL-41 - W. MAIN AND BRADLEY

Antiquated signal - all equipment in poor condition
 Scheduled for full replacement 2010
 Ped signal head on SW corner facing north is not functioning
 Unable to activate ped phase with either ped button
 No evidence of detectors
 ADA ramps with textured surface on SW and SE corners, no ramp at NW corner

Full replacement already scheduled

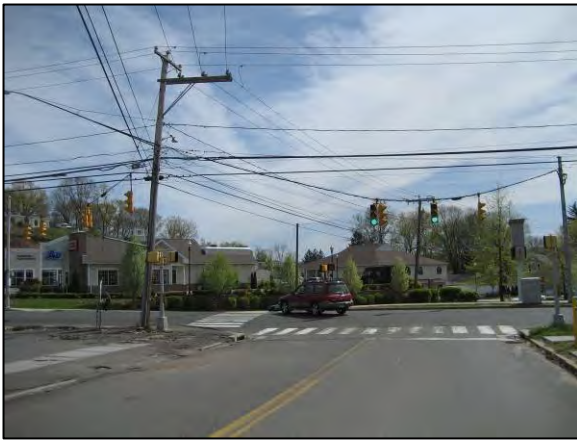
(left) West Main and Home SB

Notes Ped signal at corners of Home and W. Main are in poor condition
 Signal heads too close to stop bar on NB approach
 Vertical clearance insufficient

Recommendations Full replacement

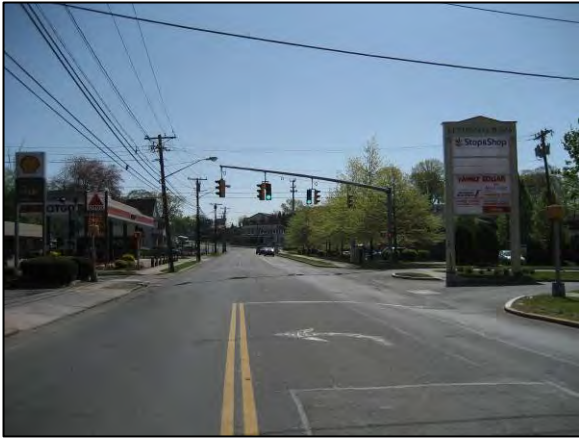
(left) West Main and Vale EB

Notes Signal heads too close to stop bar on NB approach
 Vertical clearance insufficient
 ADA ramp at NW corner in poor condition

Recommendations Relocate stop bar to provide sufficient distance to signal
 Raise signals to provide sufficient vertical clearance
 Install pedestrian push button on the median crossing NB leg
 Repaint pavement markings

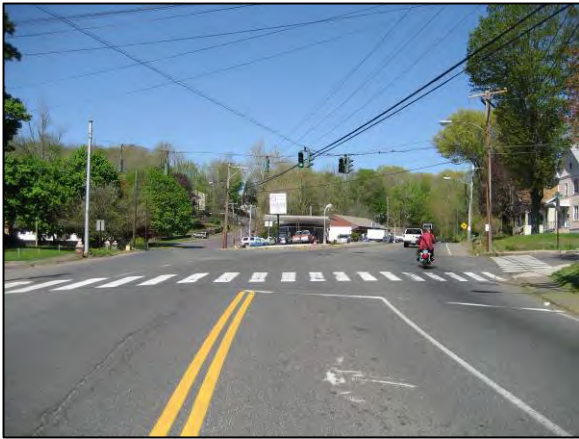
(left) West Main and Sylvan Ave WB

Notes
 Signal in overall poor condition
 WB signal head malfunctioning
 No ADA ramp at NW corner, poor sightlines, SB approach
 Size of vehicle indications too small
 Inadequate vertical and horizontal clearances to signal heads
 Insufficient distance between stop bar and signal on NE approach

Recommendations Full replacement

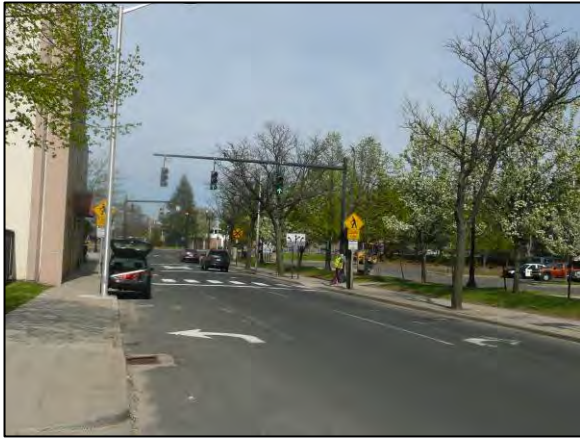
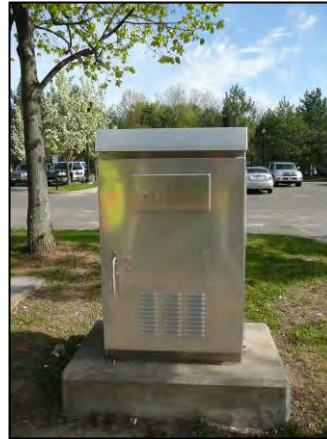
Location: TL-46 - HANOVER MID BLOCK SENIOR CENTER

Notes Vehicle heads too close to stop bar

Recommendations Relocate stop bar to provide sufficient distance to signal head

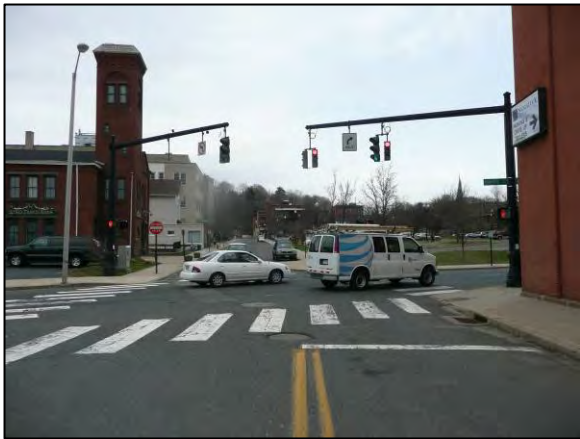
(left) NB on Butler

Notes Mixed size signal faces
 Missing mast arm sign
 Preemption for EB

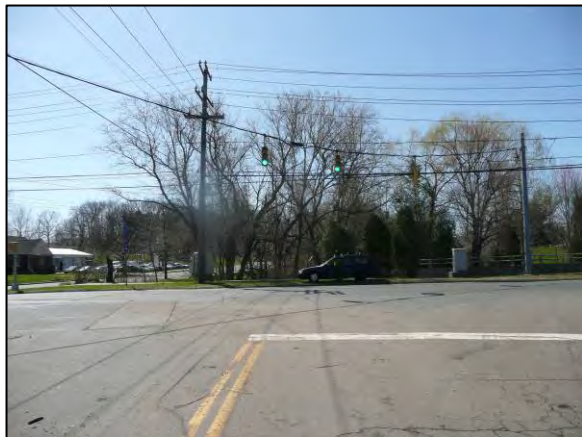
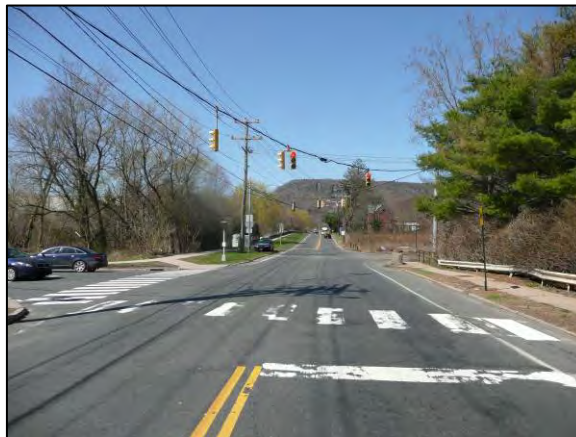
Location: TL-57 - LEWIS AND KENSINGTON

Notes Poor drainage on SB Approach
Old equipment, 8" signal faces
